HOW TO BUILD A MISSISSIPPIAN HOUSE: A STUDY OF DOMESTIC  
ARCHITECTURE IN WEST – CENTRAL ALABAMA

A THESIS

Submitted in partial fulfillment of the requirements  
for the degree of Master of Arts in  
the Department of Anthropology in the  
Graduate School of  
the University of Alabama

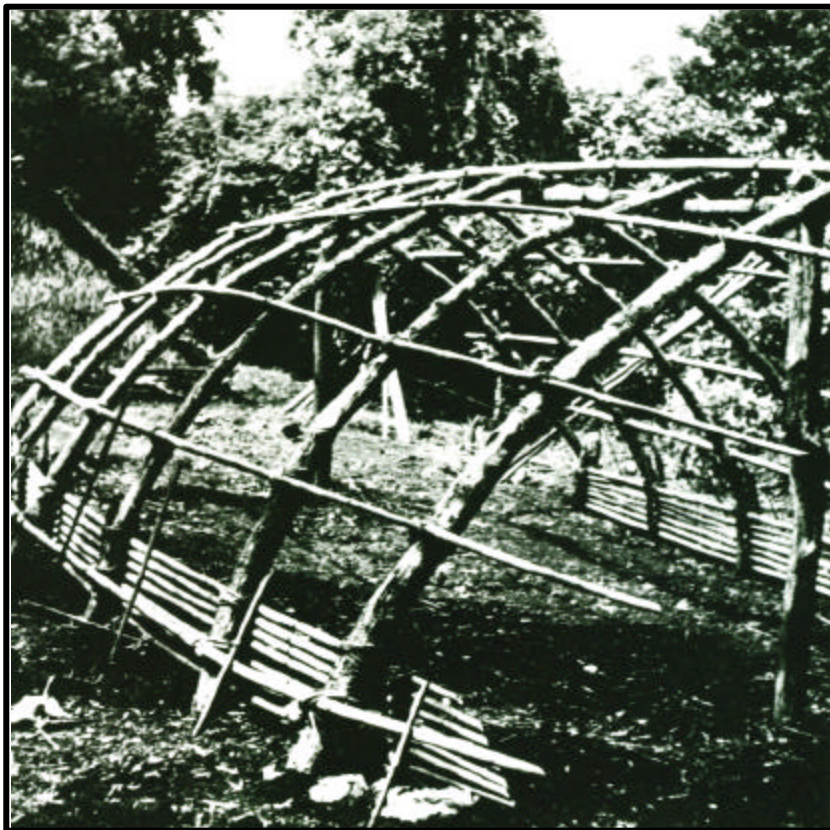
Figure 11. A New Hebridian flexed pole house in Melanesia that possesses two internal roof supports used to hold up a ridge pole in the center of the structure (from Guidoni 1975: 122).

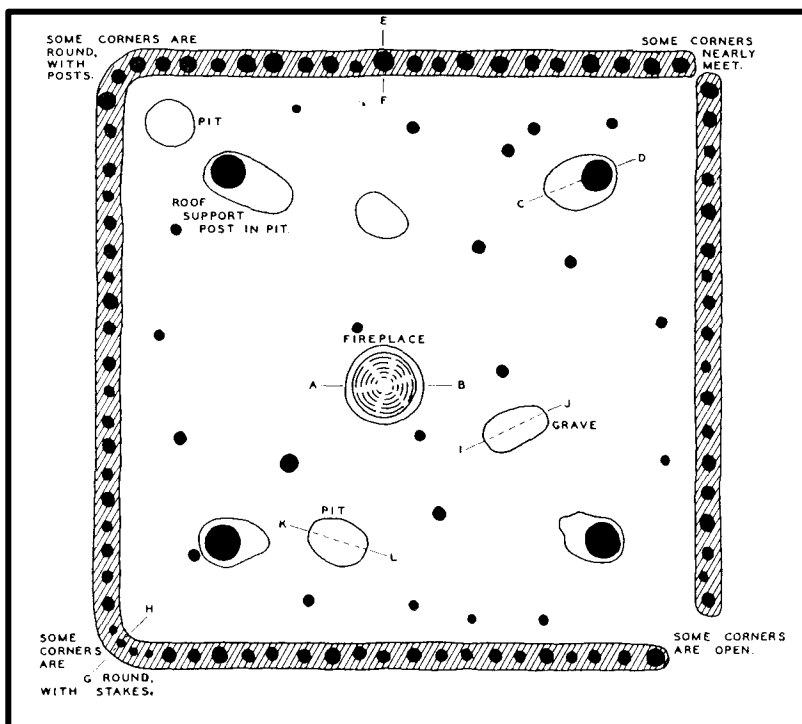
Figure 24. The idealized floor plan Black used to create his architectural reconstruction. Note the varieties of trench connections. Some are open with others meeting or continuous (Black 1944: 489).

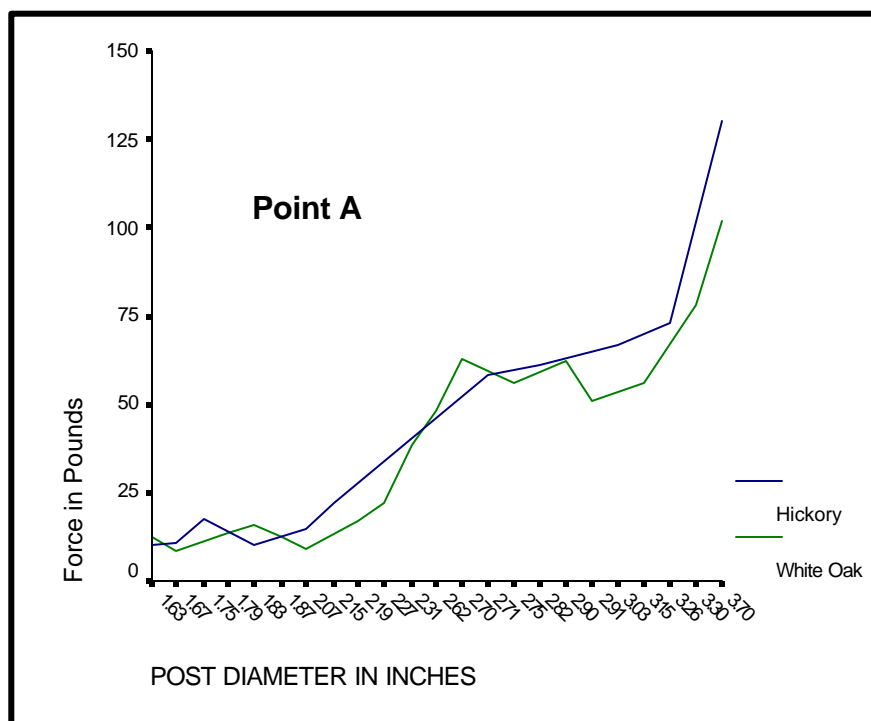
Figure 37. Line graph showing the amount of force necessary in pulling down the top of the pole by post diameter.

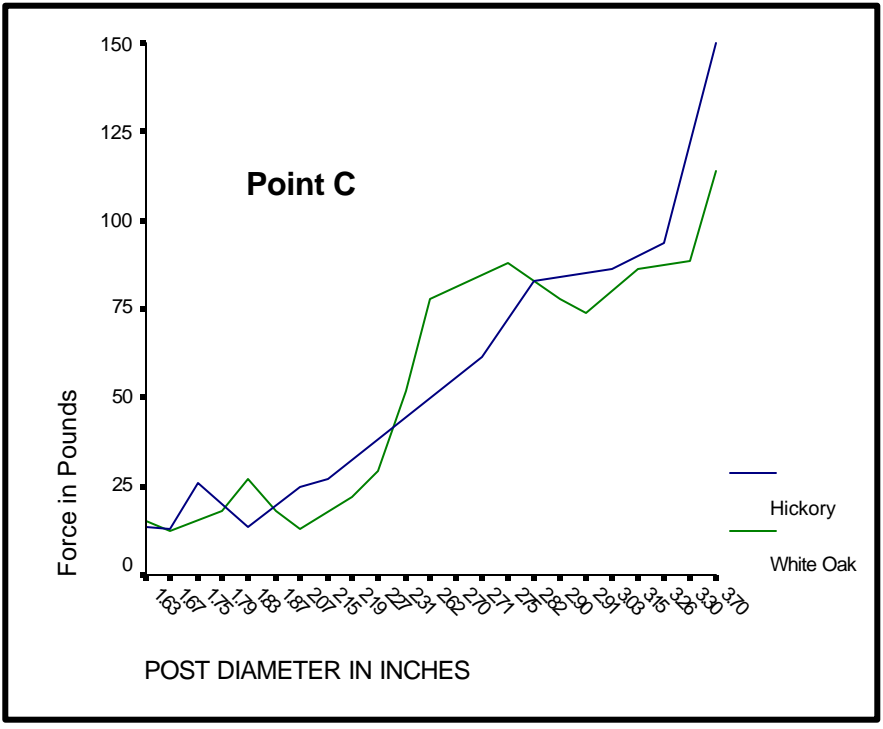
Figure 39. Line graph showing the amount of outward force at the base of the wall trench by post diameter.

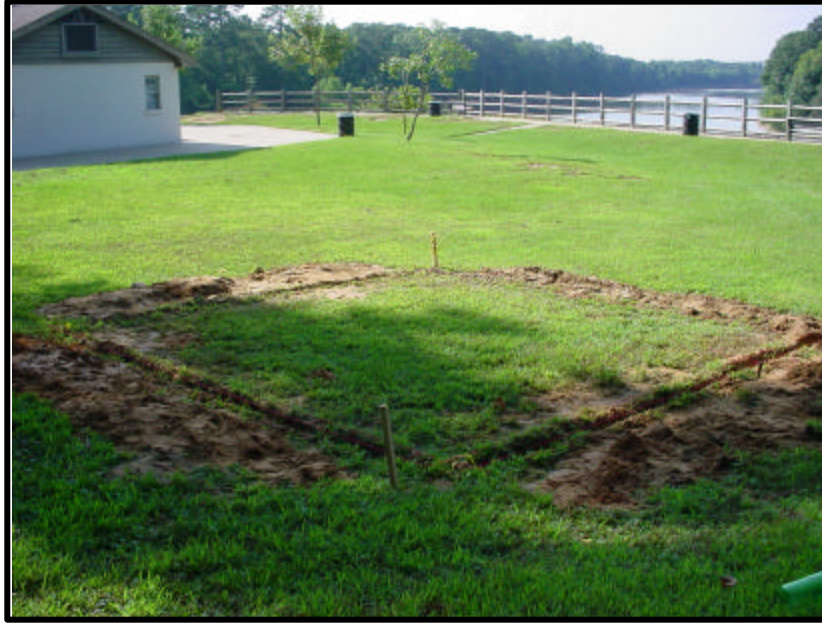
Figure 42. The wall trenches of the experimental structure.

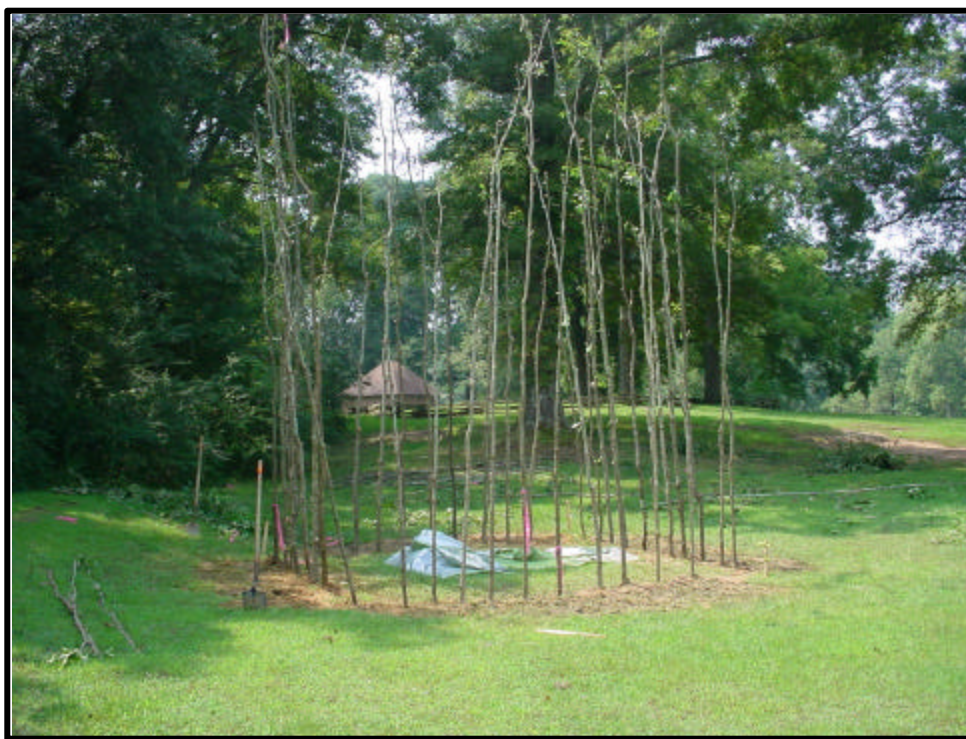
Figure 43. The poles after the dirt had been packed back into the wall trench. The larger diameter poles are in the center of the trench.

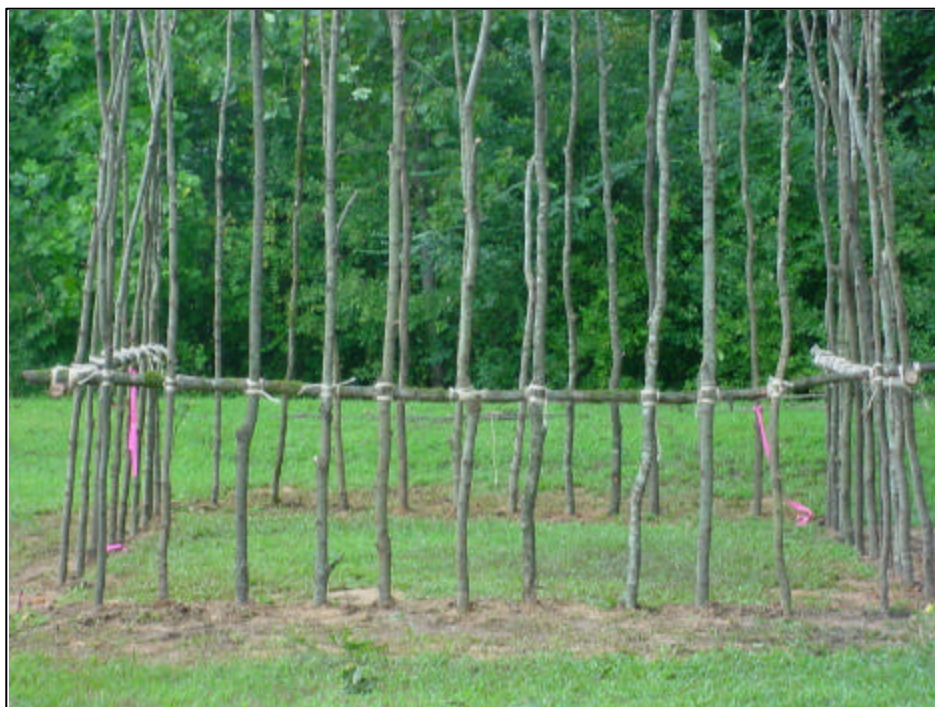
Figure 44. The experimental structure after the addition of the horizontal supports.

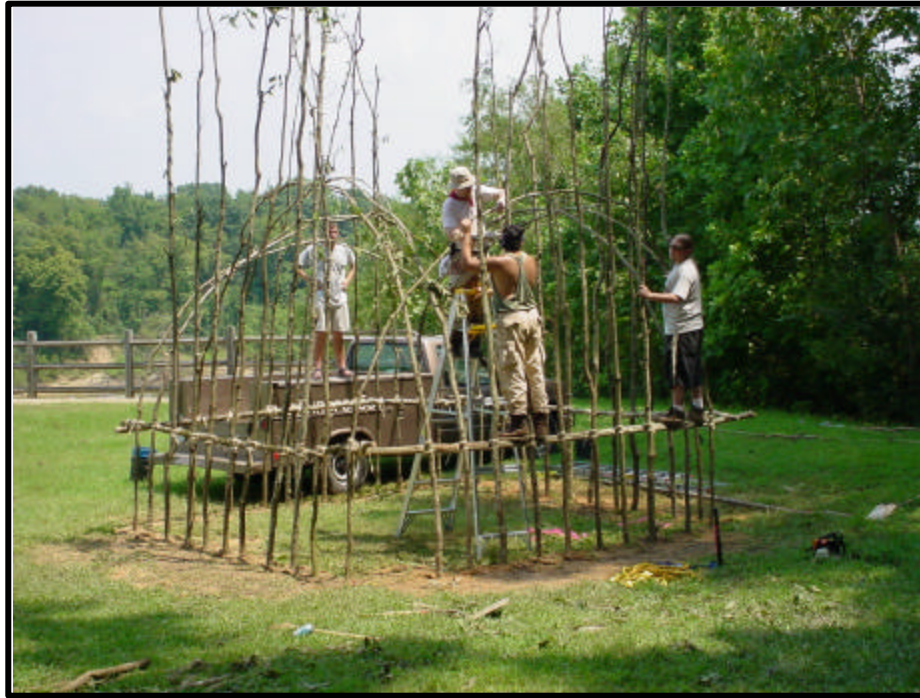
Figure 45. The beginning of the bending process. The poles were bent in sets of two, starting with the outermost poles of each trench and working in towards the center.

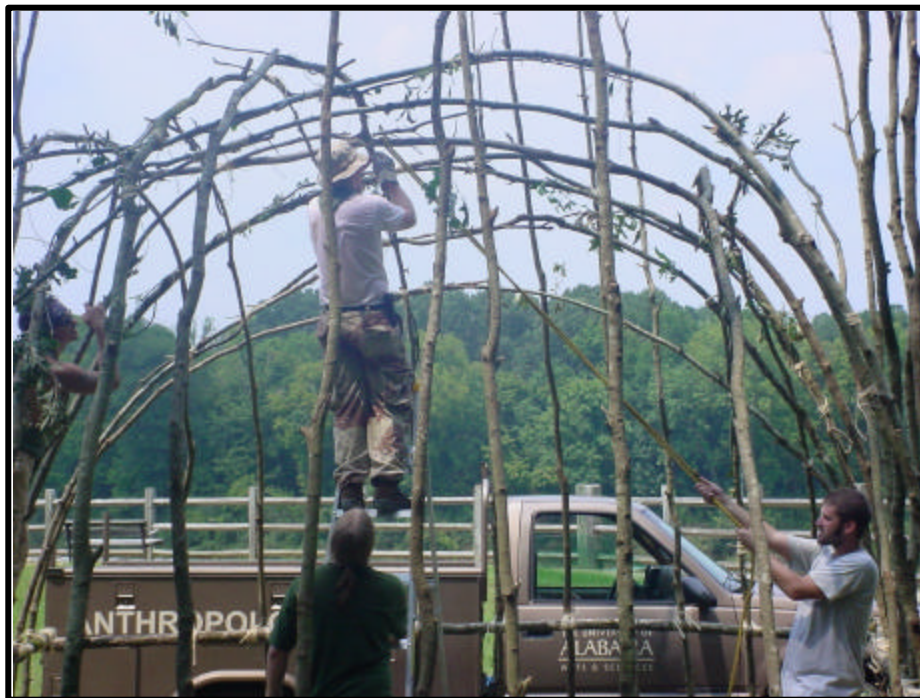
Figure 46. The middle of the bending process. Most of the poles are tied, but the four in the center of the wall in the foreground are still straight.

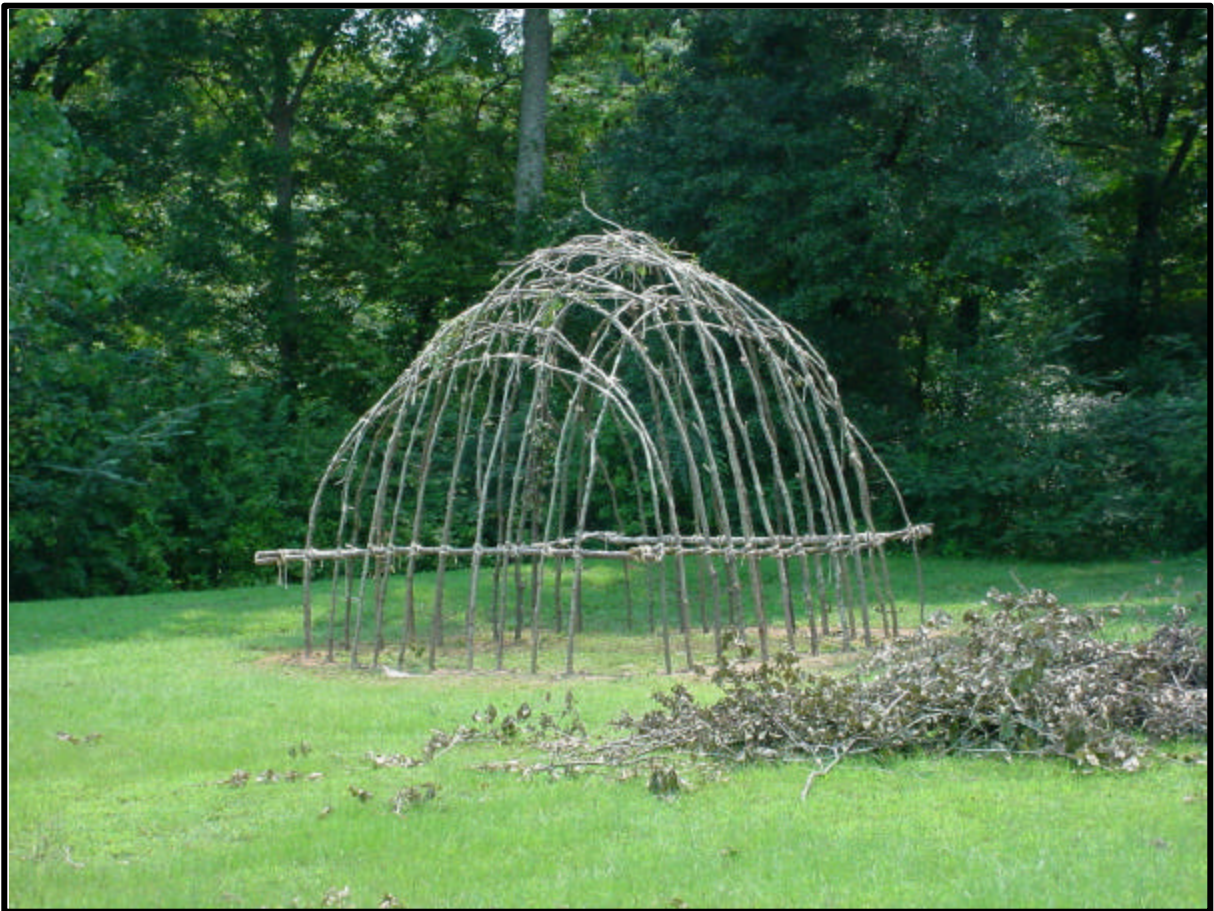
Figure 47. The completed wooden framework of the structure.

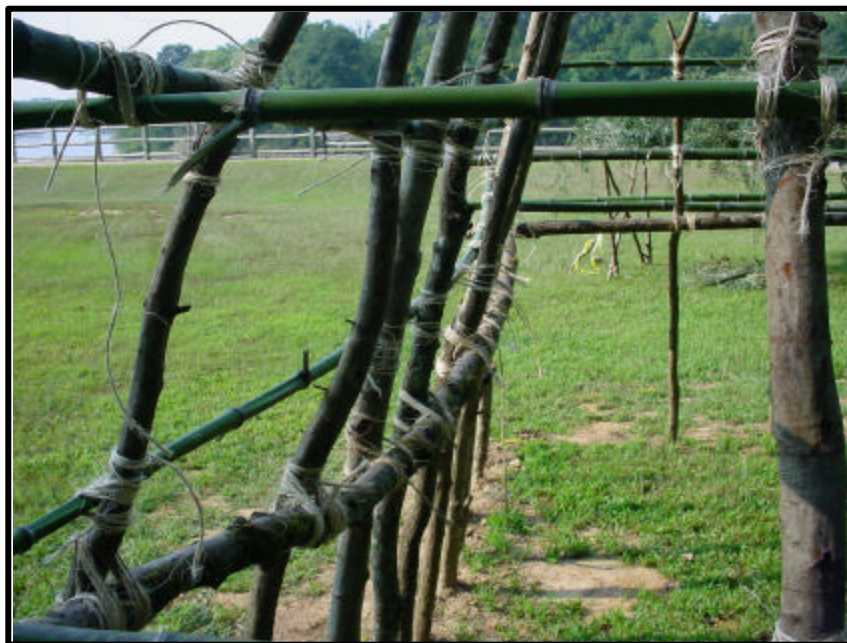
Figure 48. Photograph demonstrating the inward force on the horizontal supports. Note the piece of cane behind the supports which shows the position of the pole before the bending.

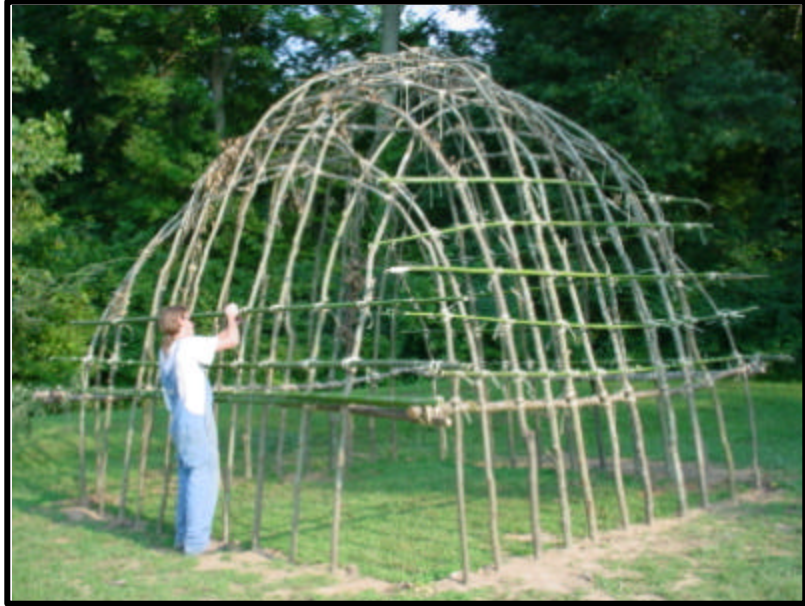
Figure 49. The complete framework with cane horizontal supports tied on. Note how the cane poles are positioned above the horizontal support and continue until the interwoven framework is reached.

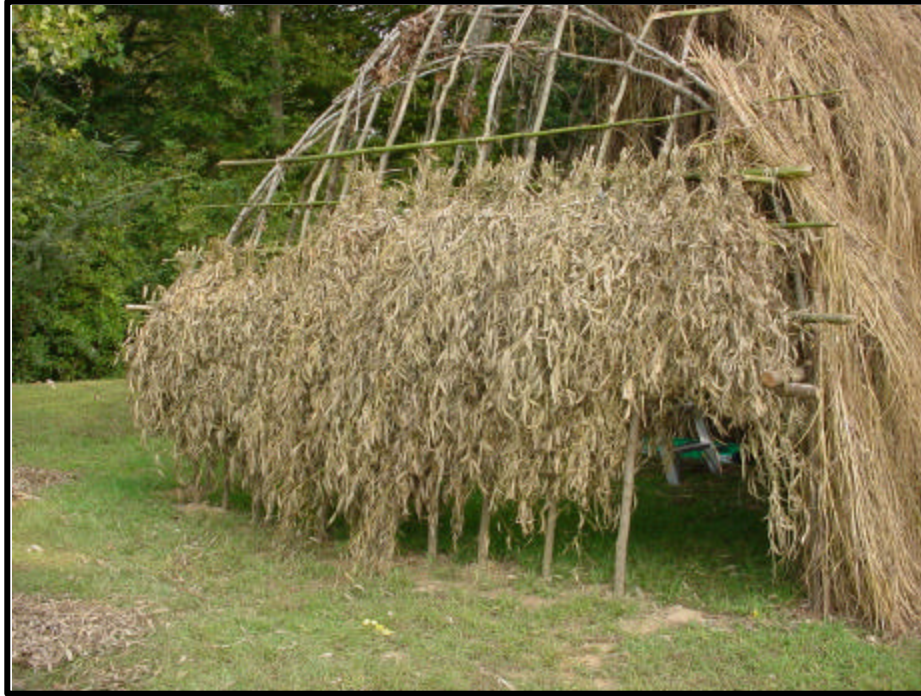
Figure 50. Experimentation with the leafy branches of river cane, stripped from the cane stringers, and used as thatch. Note how thick it is, but at the same time how much shorter the cane branches are than grass, visible to the right.

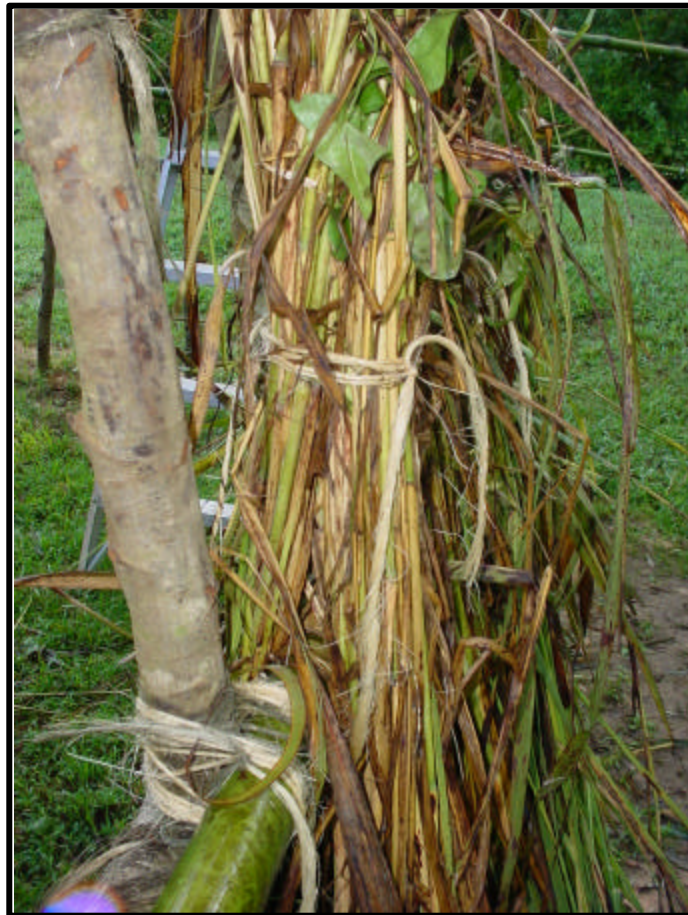
Figure 51. The grass thatching, illustrating how each bundle was hung over the cane stringers. The tied bundles were added from the bottom stringer up to the smoke hole.

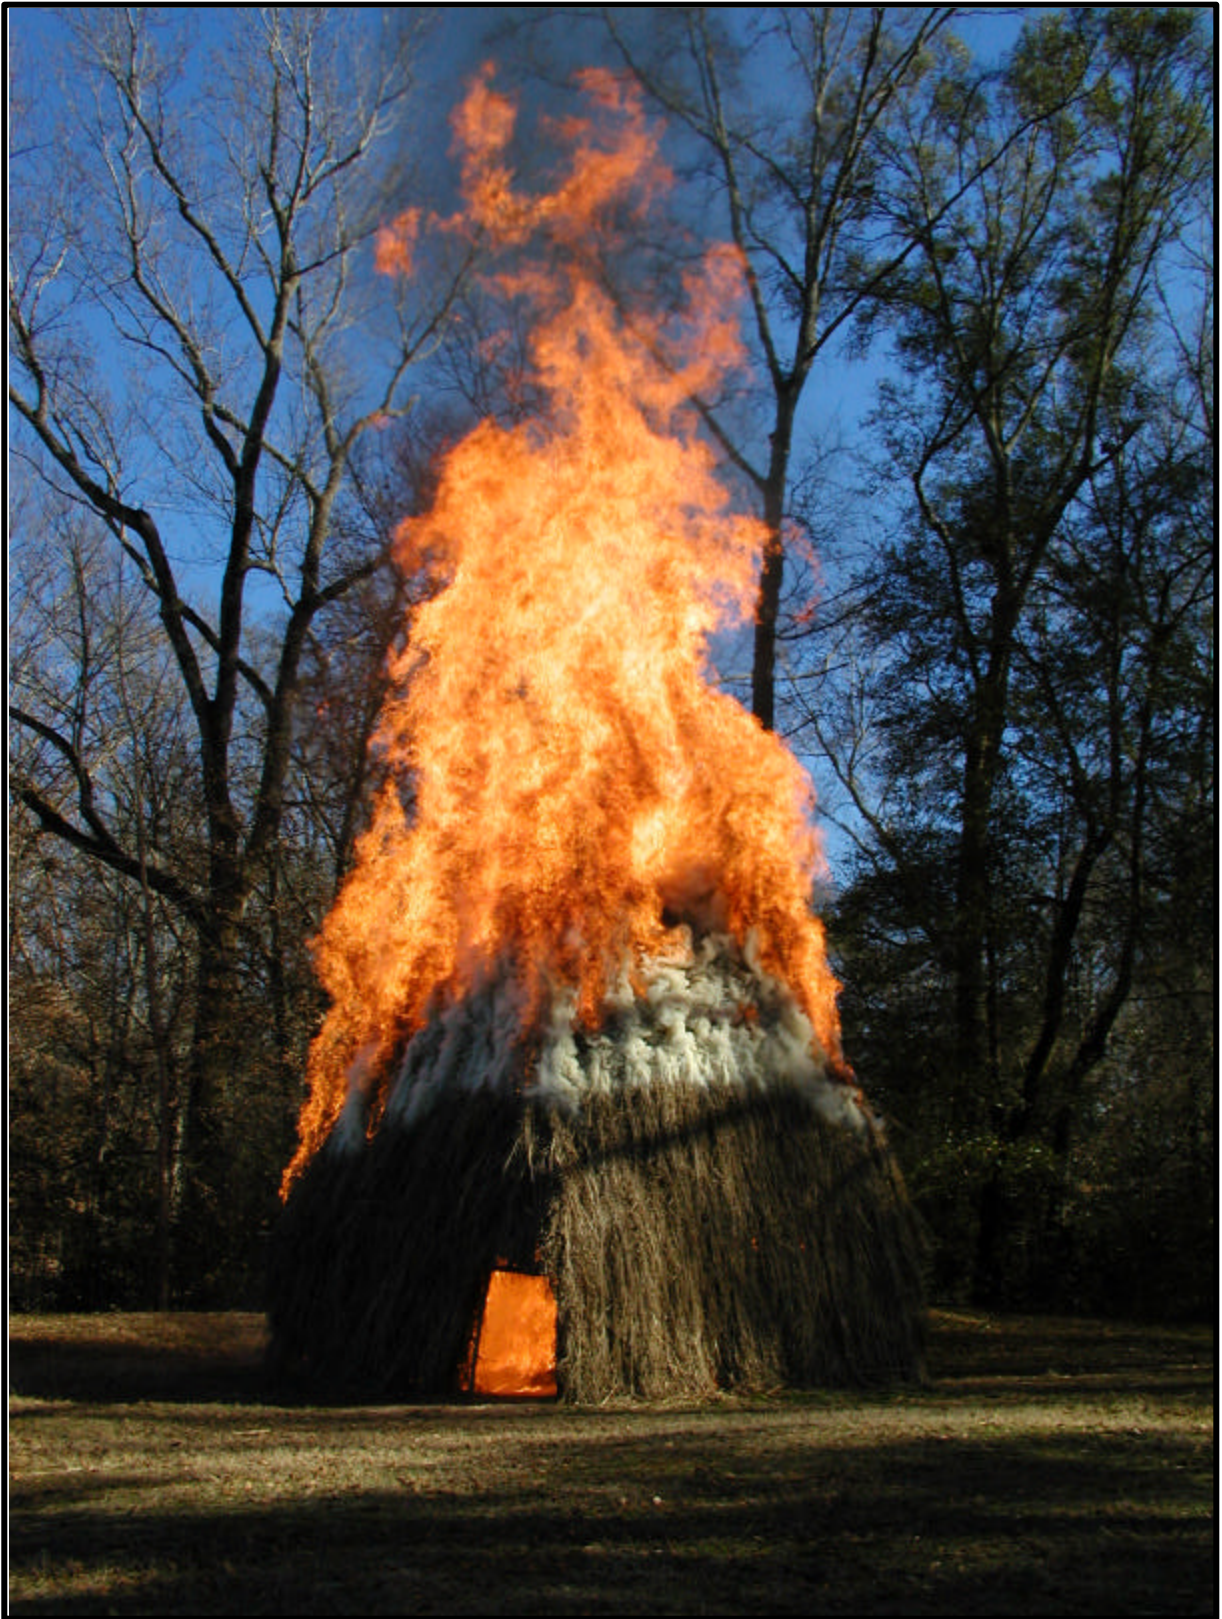
Figure 53. The experimental house after being set on fire from the inside, approximately 45 seconds after lighting the fire.

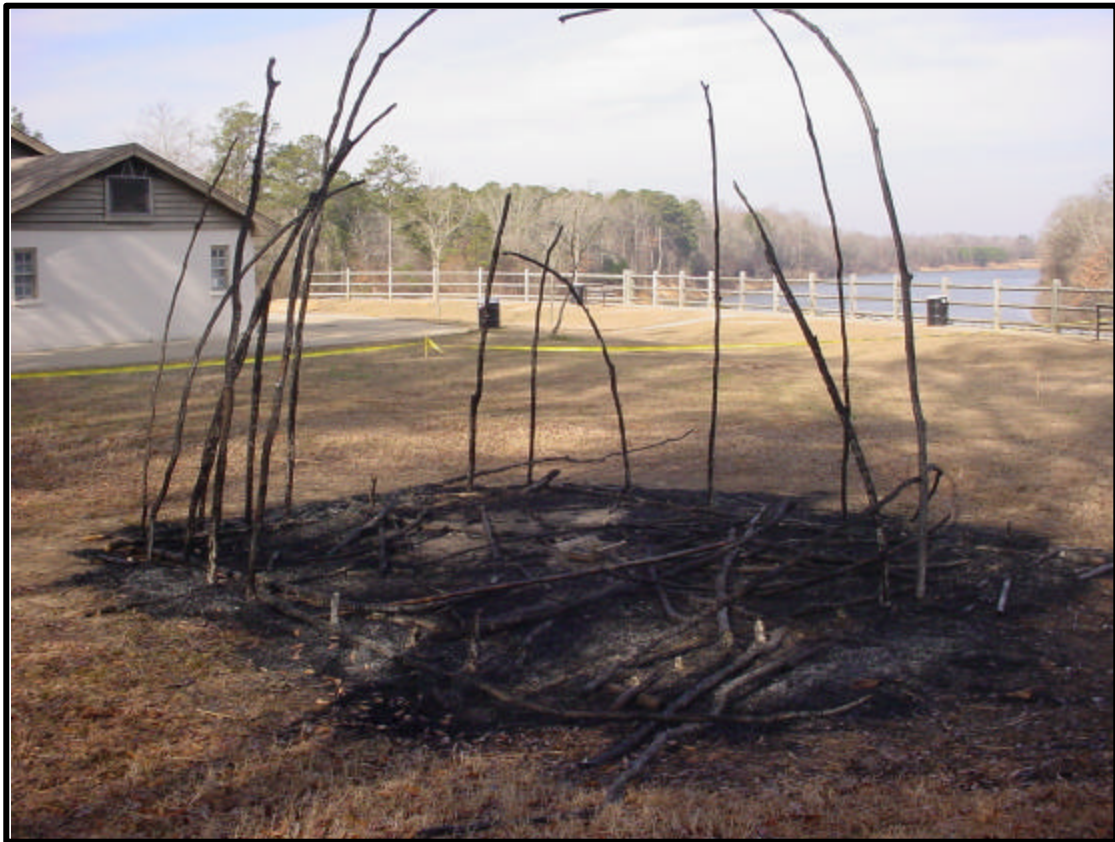
Figure 54. The burnt remains of the house, lying as they fell. Note how most poles were burnt through at the base, but otherwise remain intact.

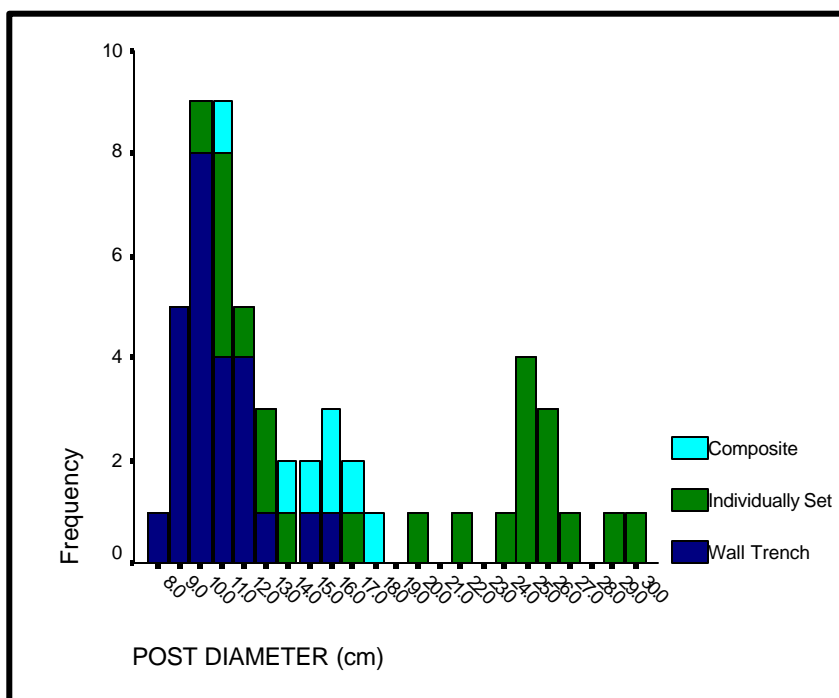
Figure 55. Histogram showing the frequency of post diameters according to whether the wall posts were in a wall trench, individually set, or in a house combining both. Note that the distribution is bimodal and that the two modes sort by insertion technique.

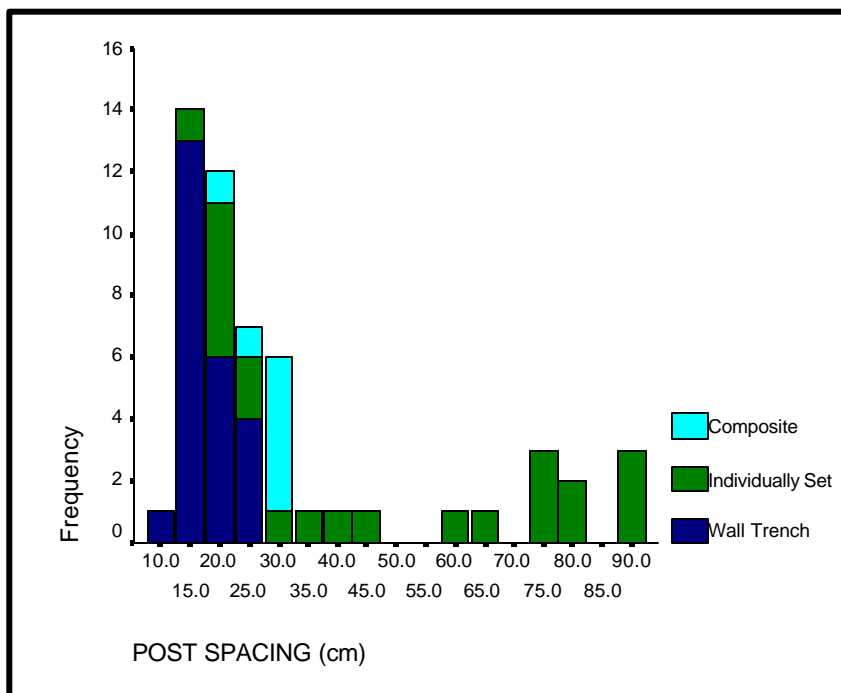
Figure 56. Histogram showing the frequency of wall post spacing, sorted by method of insertion. Note that the distribution is again bimodal, as in Figure 55.

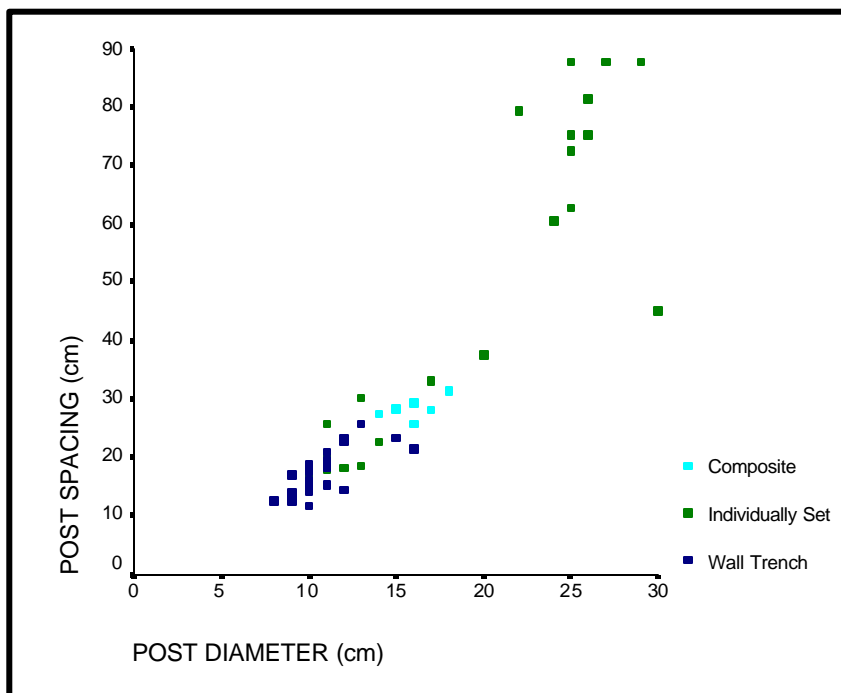
Figure 57. Scatterplot showing the correlation between post diameter (x axis) and post spacing (y axis). The data are grouped by post insertion technique.

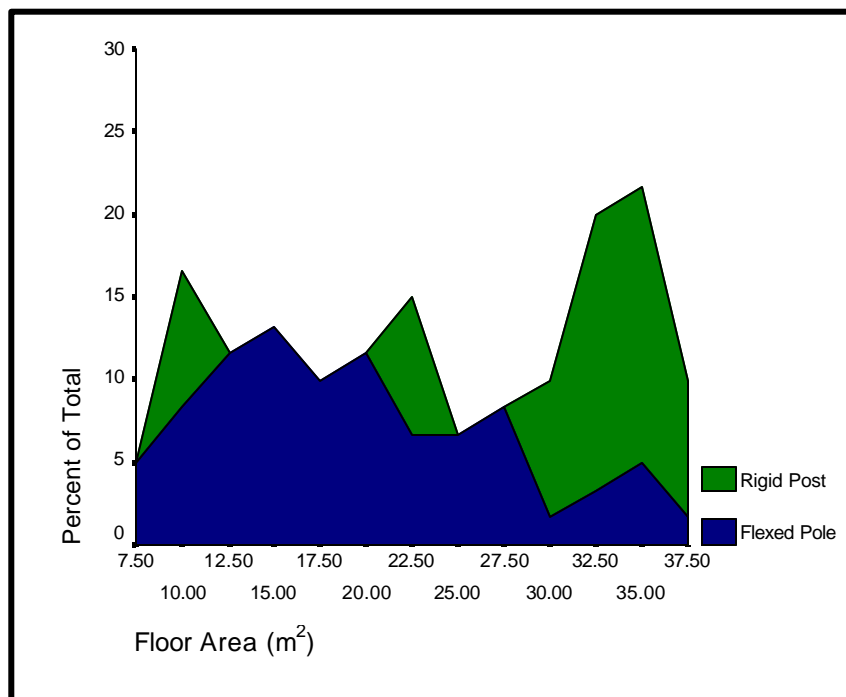
Figure 59. Chart illustrating floor area by architectural type.
