SEEKING CLARITY IN POSTHOLES:
AN EXAMINATION OF COLES CREEK EARTHFAST ARCHITECTURE

Honors Thesis
Curriculum in Archaeology
University of North Carolina at Chapel Hill

2015

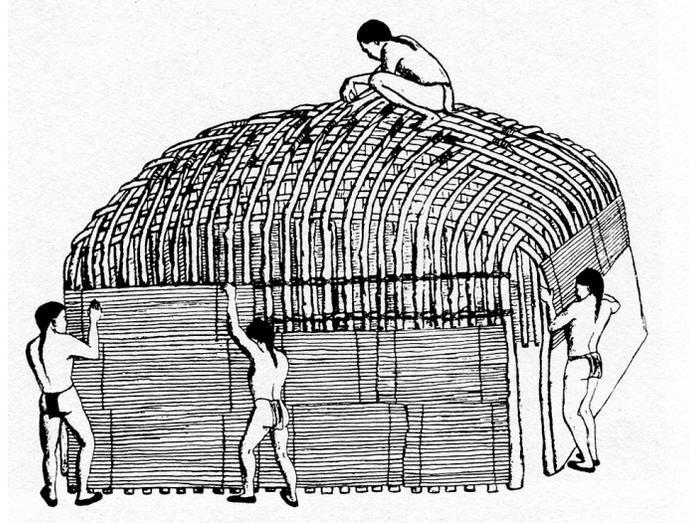
Figure 1. "Pole Construction" as illustrated by Lewis and Kneberg (1995: Figure 4.2).

(1995:55, 67). The former, called “pole construction,” was interpreted as having “unified wall and roof construction.” Termed “bent-post construction” in this study, this meant that long, flexible poles were placed in the wall trenches and bent over to form the roof, likely resulting in a dome-like shape (Figure 1). Lewis and Kneberg noted wedges within trenches that could have resisted the outward forces generated by the bent poles. They also cited examples of postmolds that were clearly bent inward within the wall trench. At the Hixon site, the charred poles were up to 25 feet long and were interwoven, clear evidence that these posts were bent over to form the roof (Lewis and Kneberg 1995: 56-60). The latter type of construction, termed “log construction” (“rigid-post construction” will be used elsewhere here) was interpreted as having rigid walls with roof beams attached above (Figure 2). Charred evidence suggested that wattle and daub was placed between wall posts. Many of the dwellings of log construction were built in shallow pits. Lewis and Kneberg noted that the pole buildings were common in earlier stratigraphic levels than the log buildings, suggesting temporal changes in construction methods within the Mississippi period (1995:67-68).

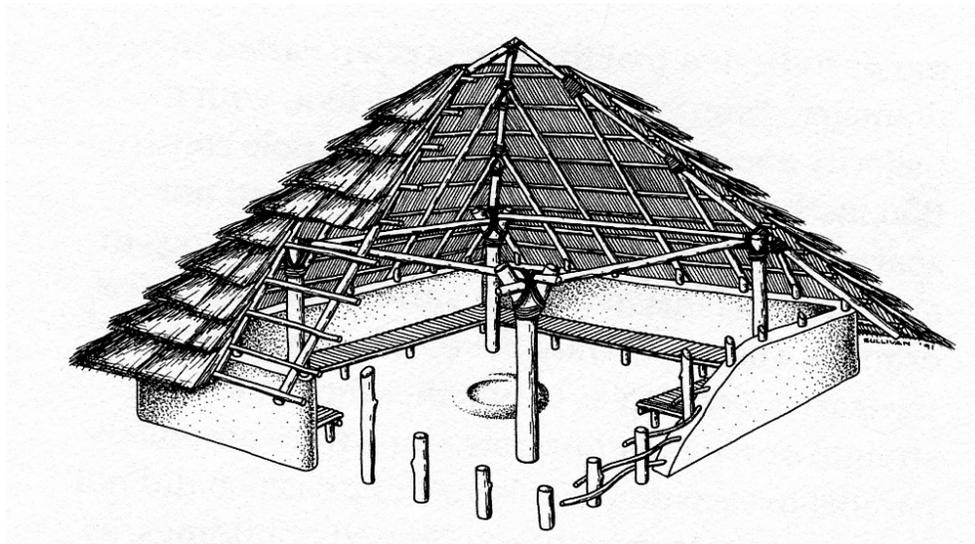
Figure 2. "Log Construction" as drawn by Brian Sullivan (Lewis and Kneberg 1995: Figure 4.9).

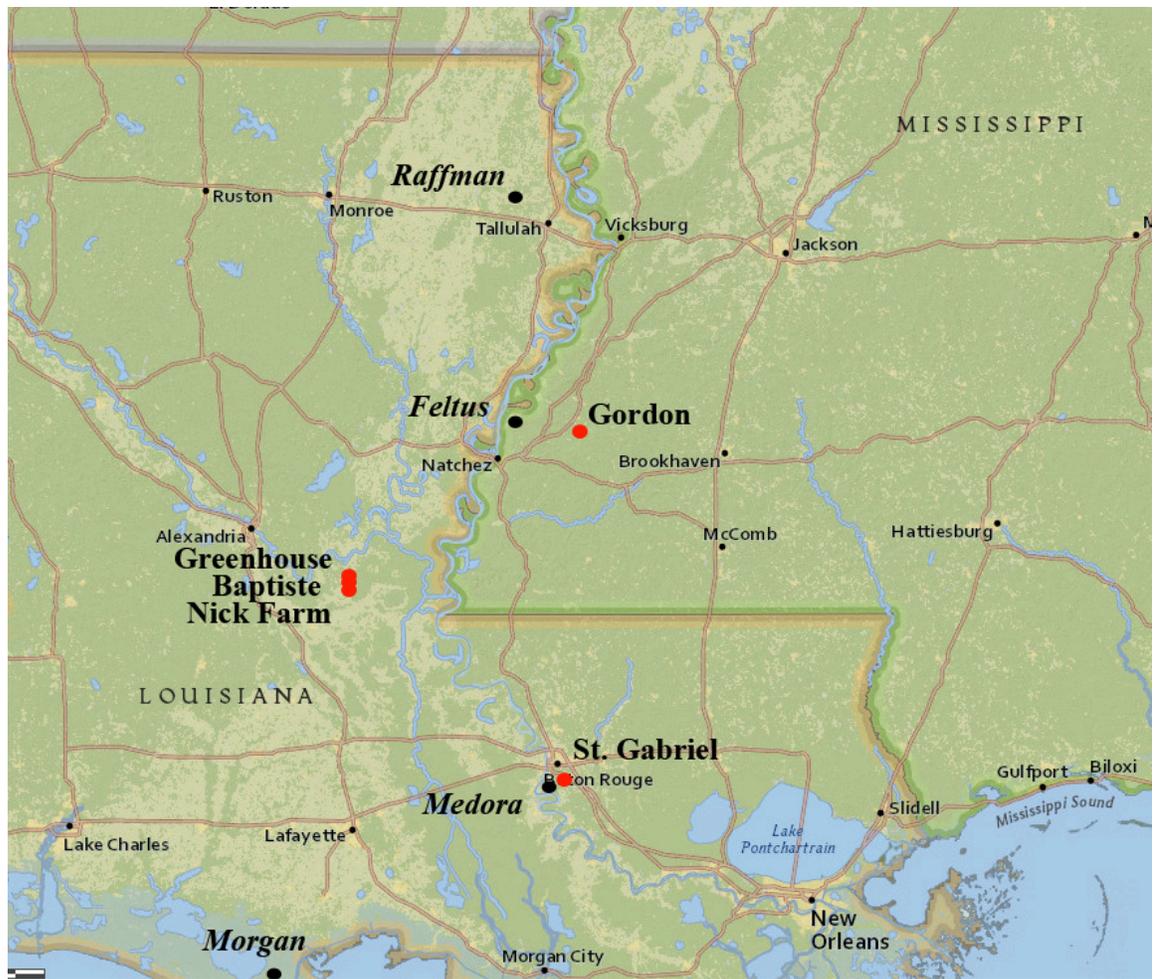
Figure 3. Distribution of Coles Creek sites studied. Sites studied are marked in red. Other relevant Coles Creek sites with architecture are marked with black. Basemap courtesy of National Geographic and ESRI.

This study of Coles Creek earthfast architecture includes evidence from five sites from Mississippi and Louisiana (Figure 3). Baptiste, Greenhouse, and Nick Farm sites, located in Avoyelles Parish, Louisiana, were excavated by the Works Progress Administration between 1938 and 1940, under the direction of James A. Ford and Robert S. Neitzel. Neitzel managed the excavations in the field (Ford 1951:12; Schwab 1998:2; Whitmer 1987:3). Gordon site, in the Natchez Bluffs, was excavated by John L. Cotter prior to the 1950s (Cotter 1952). St. Gabriel site near Baton Rouge was excavated by Deborah K. Woodiel in the 1970s (Woodiel 1993). As a result, this study focuses heavily on WPA information from sites in the Marksville area, with some architecture from the northwest in the Natchez Bluffs, and a little from near Baton Rouge.

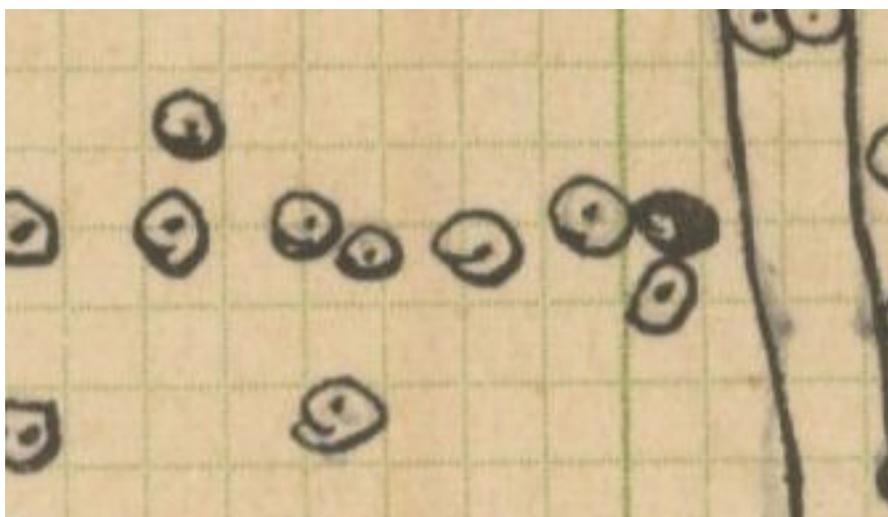
Figure 8. Detail from a feature map of Mound B at the Baptiste site (see also Figure 10). Excerpted from Map 388, Flat Map Collection, Louisiana State University Museum of Natural Science.

When high-resolution scans of structure maps from Baptiste site and Nick Farm site were obtained from Louisiana State University, it became clearly apparent how swiftly the posthole maps must have been drawn at WPA sites. It appears that the excavator, who drew the map, marked out the location of the center of the posthole on graph paper and quickly circled that point, leaving a general impression of posthole's size (Figure 8).

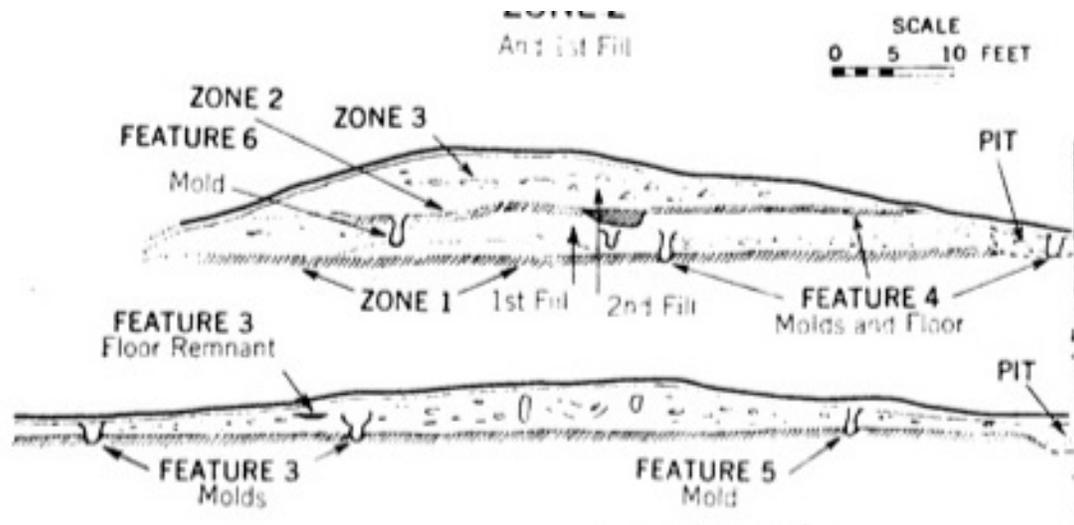
Figure 9. Profile of Mound B, Gordon site, showing slanted postholes (termed molds) with widened bases. Excerpted from Cotter (1952:Figure 53).

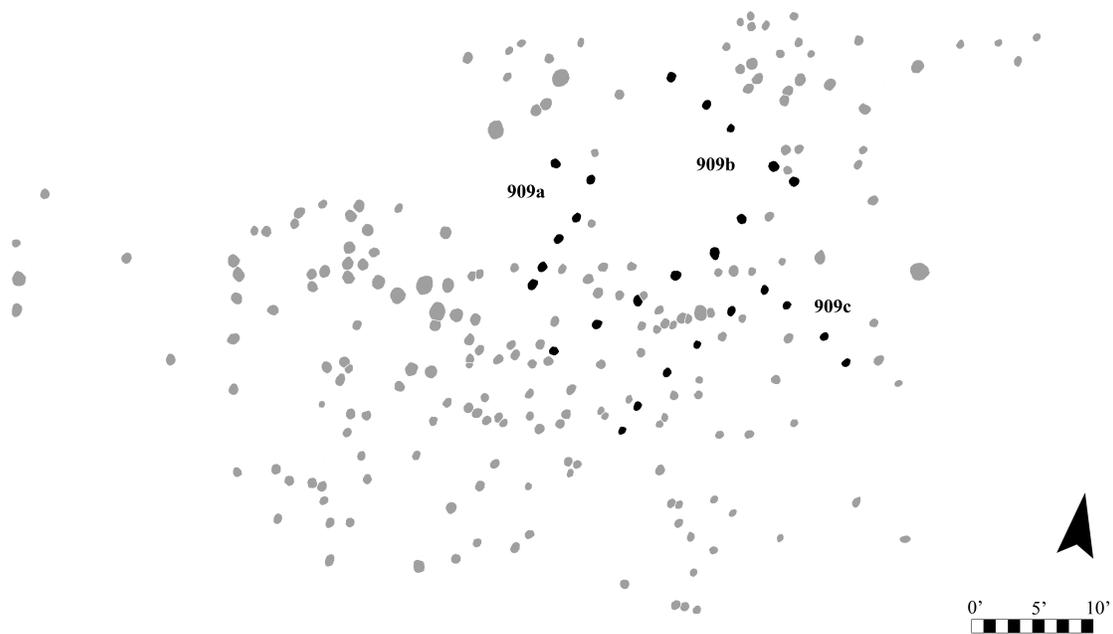
Figure 10. Feature 909, Mound A, Baptiste site. Discovered alignments are in black. Adapted from Map 533, Flat Map Collection, Louisiana State University Museum of Natural Science

alignments, although they fail to indicate clear buildings, support the idea that rectangular buildings once stood on this stage of Mound A. All three alignments suggest rigid-post construction, given the wide space between postholes. Postholes are in an intermediate zone between those of rigid-post and bent-post construction, based on parameters mentioned in the previous section. They feature widely spaced posts, but those posts are relatively narrow in dimension.

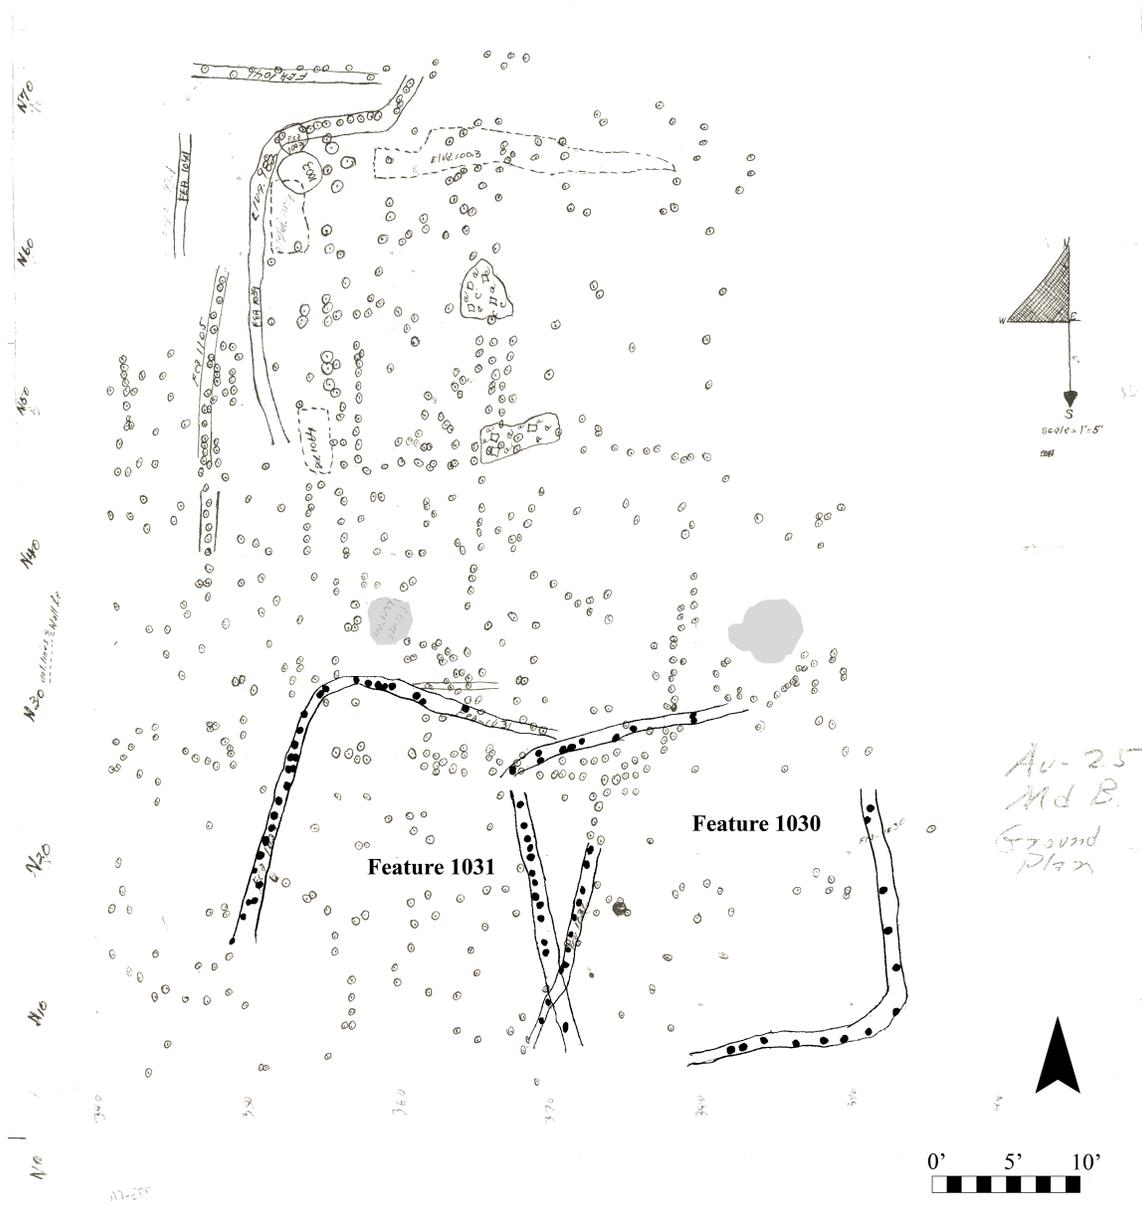
Figure 11. Features under Mound B, Baptiste site. Pit features associated with structures are colored gray. Adapted from Map 388, Flat Map Collection, Louisiana State University Museum of Natural Science.

Mound B featured extensive posthole evidence (Figure 11), including some post features found within wall trenches. These features revealed two clearly differentiated structures toward the south end of the mound (Features 1030 and 1031). Evidence for further structures was unclear but featured posts of similar diameter and spacing to those to the south of the mound. Given the clarity the two southern structures, these were taken as representative of other structural evidence on the mound, and further analysis of the post features found on Mound B was left to future study. Associated with some of the other possible structures were two patches of wattle (Whitmer 1987:Table 16).

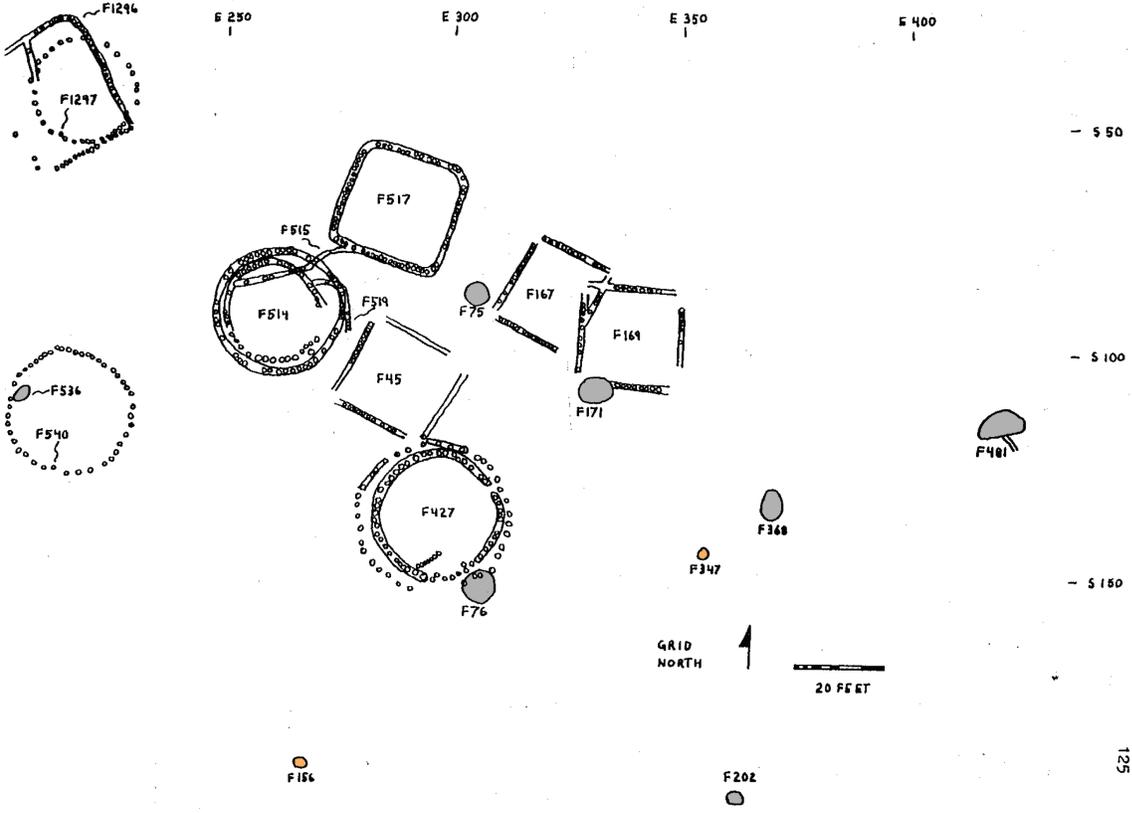
Figure 12. Baptiste Village. Hearths are colored orange; pit features are colored gray. Adapted from Whitmer (1987:Figure 39).

A well-made fire basin, four feet deep and two feet wide, was found on the floor of Level 7 (Ford 1951:36). If such a hearth was generally only found indoors, this would be strong evidence of the existence of a roofed structure. However, these sorts of fire basins are occasionally in outdoor settings, as indicated in the Village at Baptiste site (Figure 12).

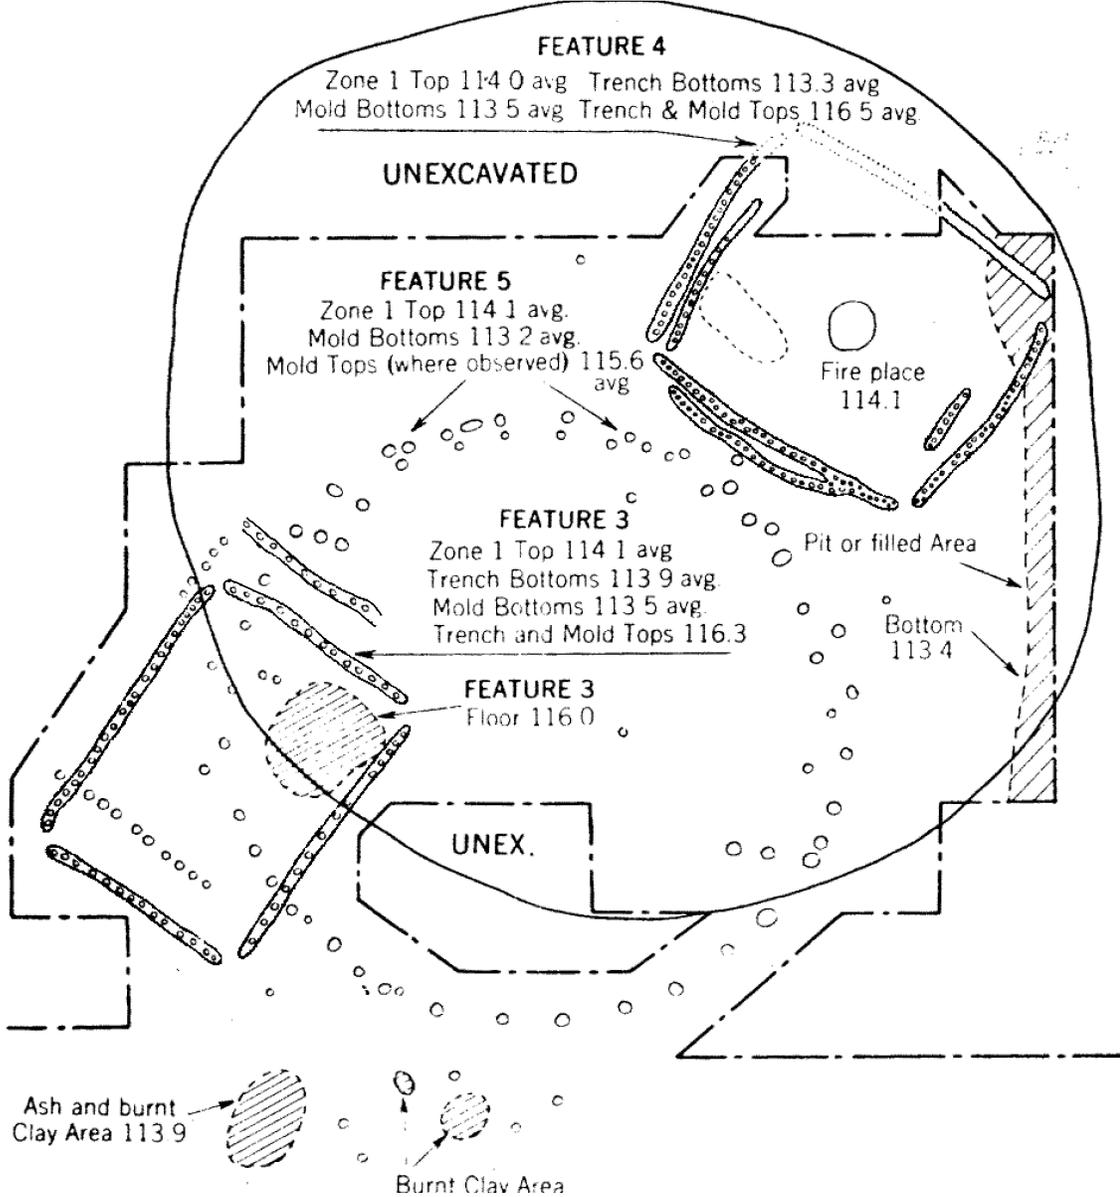
Figure 13. Architectural Evidence from Mound B, Zone 1, Gordon site. Excerpted from Cotter (1952:Figure 53).

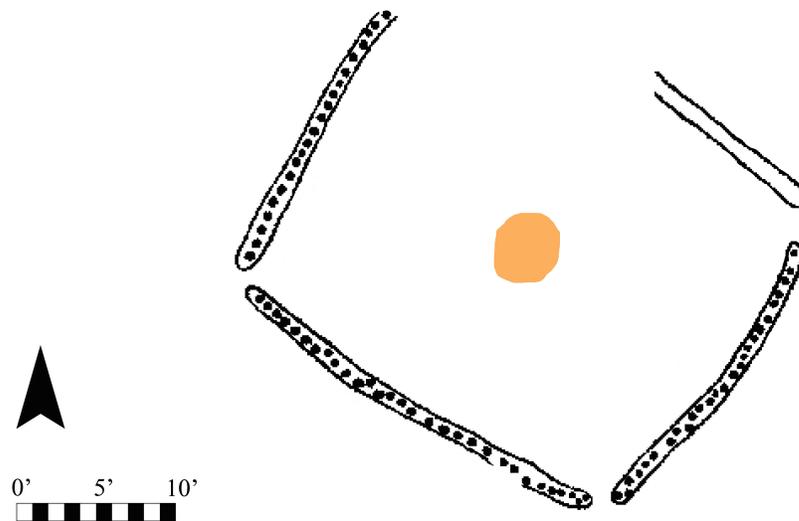
Figure 15. Feature 4a, Mound B, Zone 1, Gordon site. A hearth, possibly associated, is colored orange. Adapted from Cotter (1952:Figure 53).

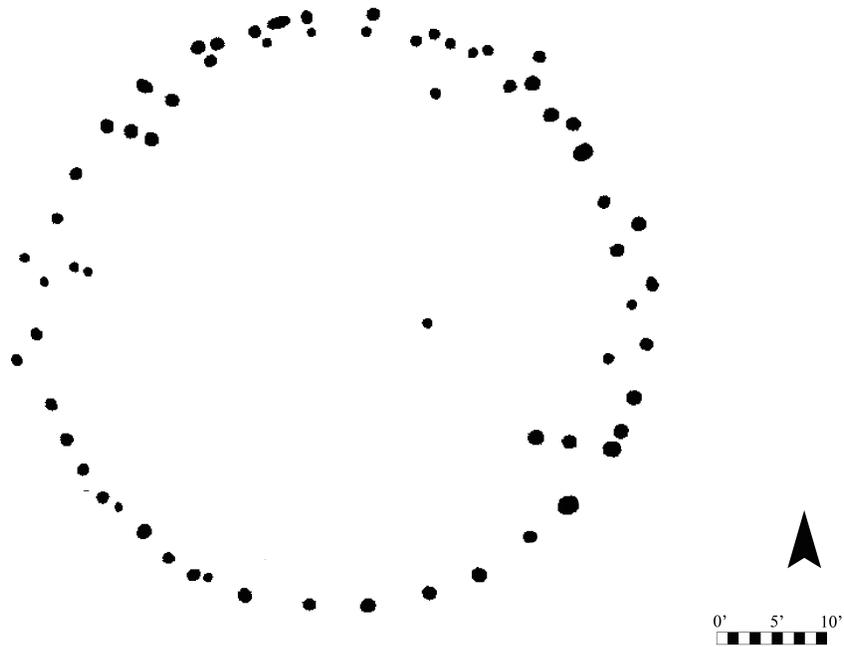
Figure 17. Feature 5, Mound B, Zone 1, Gordon site. Adapted from Cotter (1952:Figure 53).

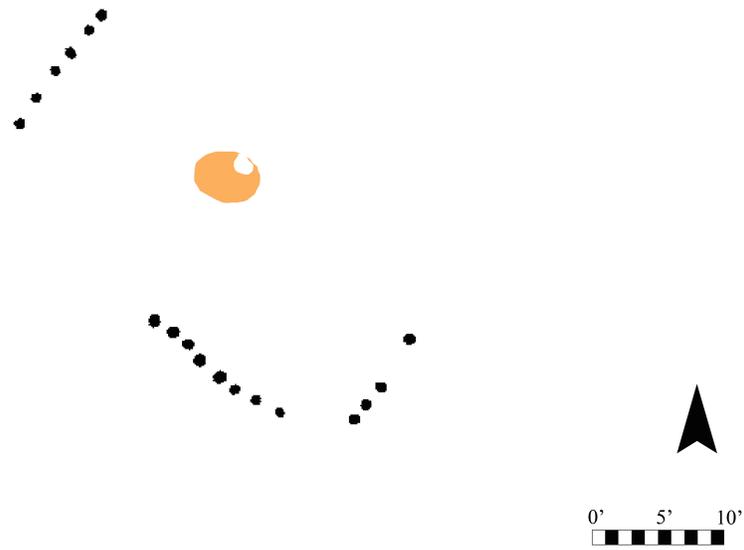
Figure 19. Feature 6, Mound B, Zone 2, Gordon site. A hearth, possibly associated, is colored orange. Adapted from Cotter (1952:Figure 53).

discovered during excavation. The basin may still be associated, as the postholes were probably discovered below the original mound surface. Based on the post size (accounting for some overestimation due to map processing) and spacing obtained from the published map, Feature 6 lies in the middle between bent-post and rigid-post construction. Given no evidence of support posts and the open-corner arrangement of posts, which would have aided in bent-pole construction, it seems more likely that Feature 6 had a bent-post form.

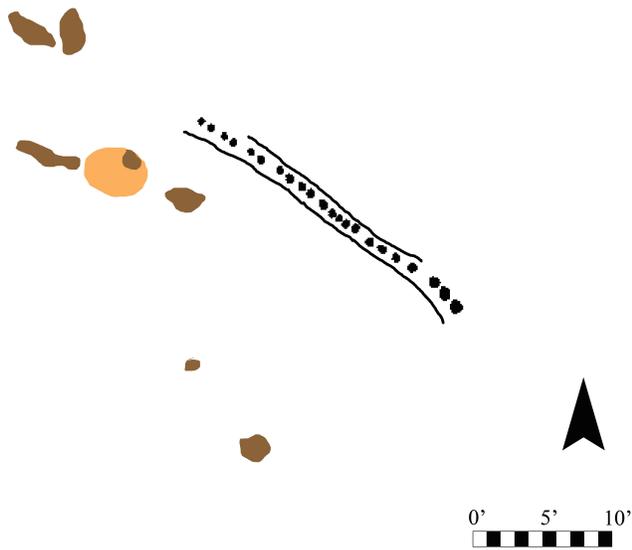
Figure 20. Feature 7, Mound B, Zone 2, Gordon site. A hearth and burials, possibly associated, are colored orange and brown, respectively. Adapted from Cotter (1952:Figure 53).

Feature 7. This feature (Figure 20) is a row of postmolds within a wall trench. The postmolds are an average of 7.6 inches wide, spaced by an average distance of 5.8 inches. This means that the postmolds are positioned in a manner that would describe bent-post architecture but are too large to hold flexible posts. This is a problem that seems universal at Gordon site and is probably the result of imprecision in map analysis, rather than the actual characteristics of the prehistoric structures. These postmolds were found beginning 2.8 feet above those of Feature 6 in the mound fill. This structure may have been associated with a hearth, as well as a number of burials found in the fill below.

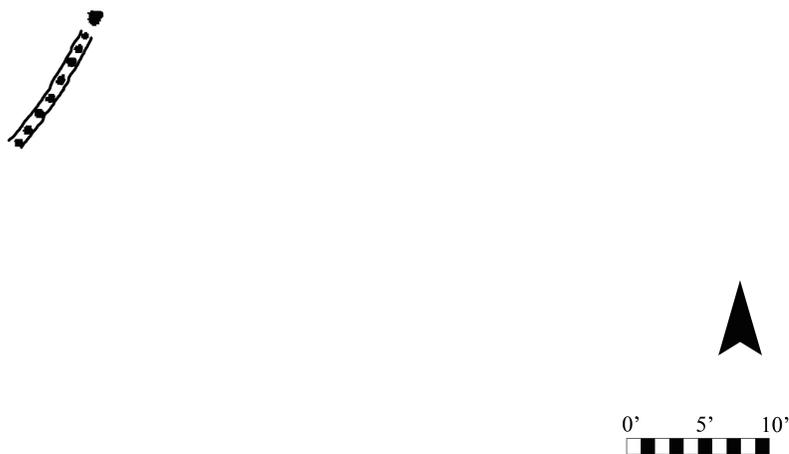
Figure 21. Feature 8, Mound B, Zone 2, Gordon site. Adapted from Cotter (1952:Figure 53).

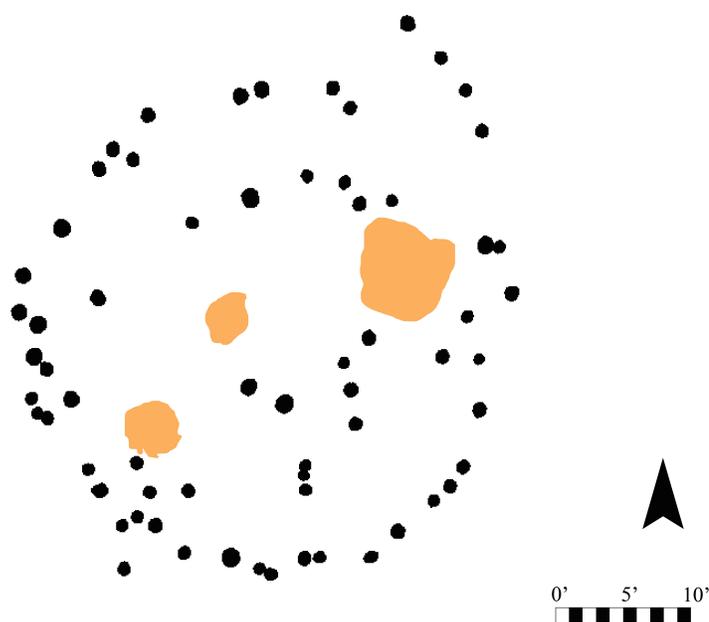
Figure 22. Greenhouse Mound A, Building Level 6. Areas of burned are clay colored orange. Adapted from Ford (1951:Figure 6).

Given the irregularity of the postholes and the absence of roof supports, it is possible that, rather than a roofed structure, these postholes could represent a post enclosure or represent screens or other light earthfast structures. Some of the postholes, such as the paired postholes, could have ritual origins, as examined in the next section.

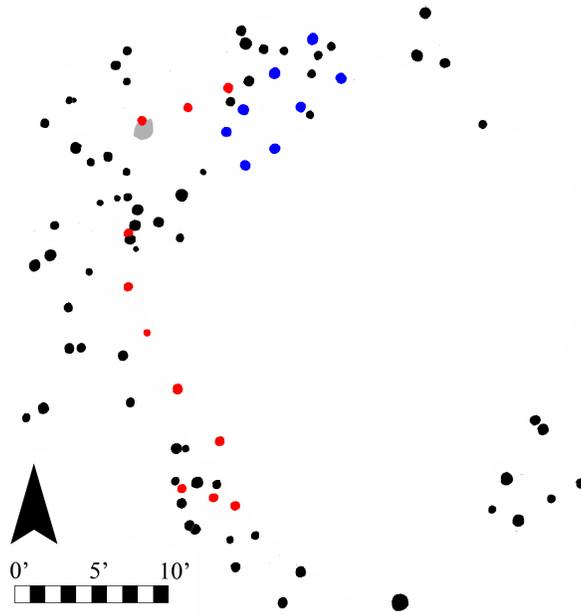
Figure 25. Greenhouse Mound F, Building Level 1, with all sub-floor posts removed, showing discovered alignments. Alignments of posts between 6 and 8 inches in diameter are colored red. Alignments of larger posts are colored blue. A small pit is indicated in gray. Adapted from Ford (1951:Figure 9).

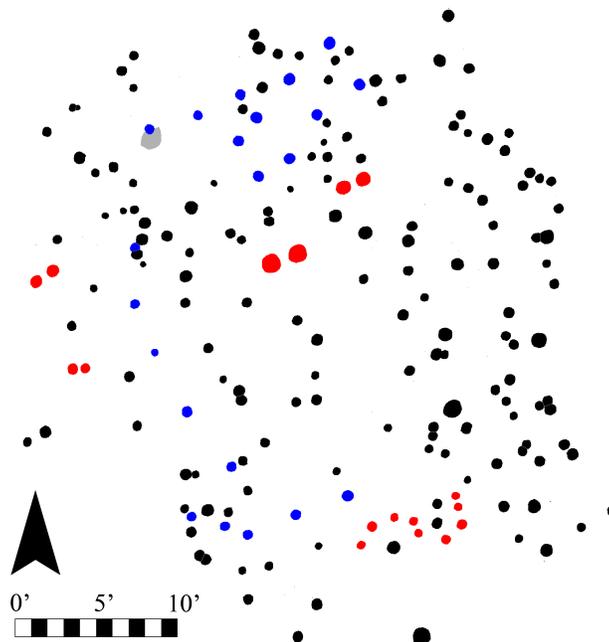
Figure 26. Greenhouse Mound F. Building Level 1. This image shows paired posts and an S-shaped alignment in red. Alignments from Figure 25, extended with additional posts, are colored in blue. Adapted from Ford (1951:Figure 9).

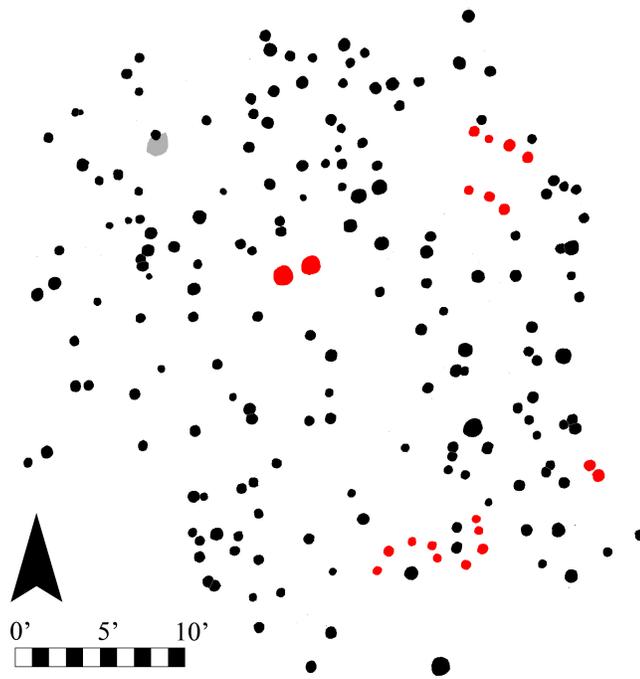
Figure 27. Greenhouse Mound F, Building Level 1. Alignments and possible paired posts resulting from Prezzano analysis are colored red. Adapted from Ford (1951:Figure 9).

Prezzano's methods were also applied to the postholes on this level (Figure 27). Linkages of certain lengths, between postholes within defined diameter ranges, again linked some of the identified pairs of postholes. Links between posts less than nine inches in diameter spaced less than 1.5 feet apart revealed a few parallel alignments in the northwest part of the map. The links also verified the S-shaped alignment to the south of the map. This analysis was unsuccessful at finding any longer alignments that clearly delineated a structure. Perhaps some of the small alignments, such as those in the northwest and the "S" shaped pattern to the south, represent light constructions, such as screens and racks, rather than buildings. The parallel alignments to the northwest could represent successive screen construction. Some of the largest posts, sometimes arranged in pairs, could be evidence of ritual post-setting.

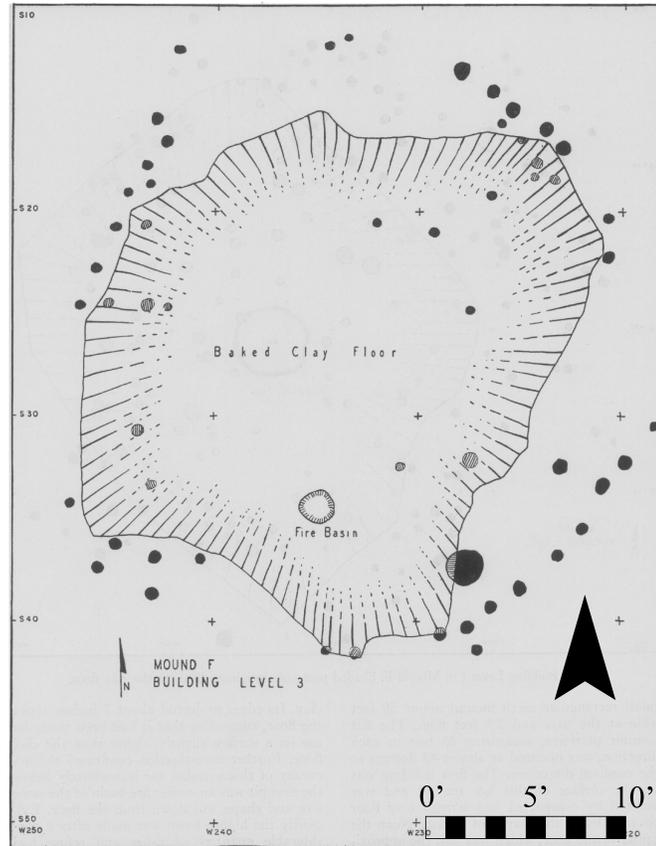
Figure 28. Greenhouse Mound F, Building Level 3. Image adapted from Ford (1951: Figure 10).

One posthole, greater than a foot in diameter, lay just inside the southeastern row of postholes and may not be associated with any structure, due to its anomalous size.

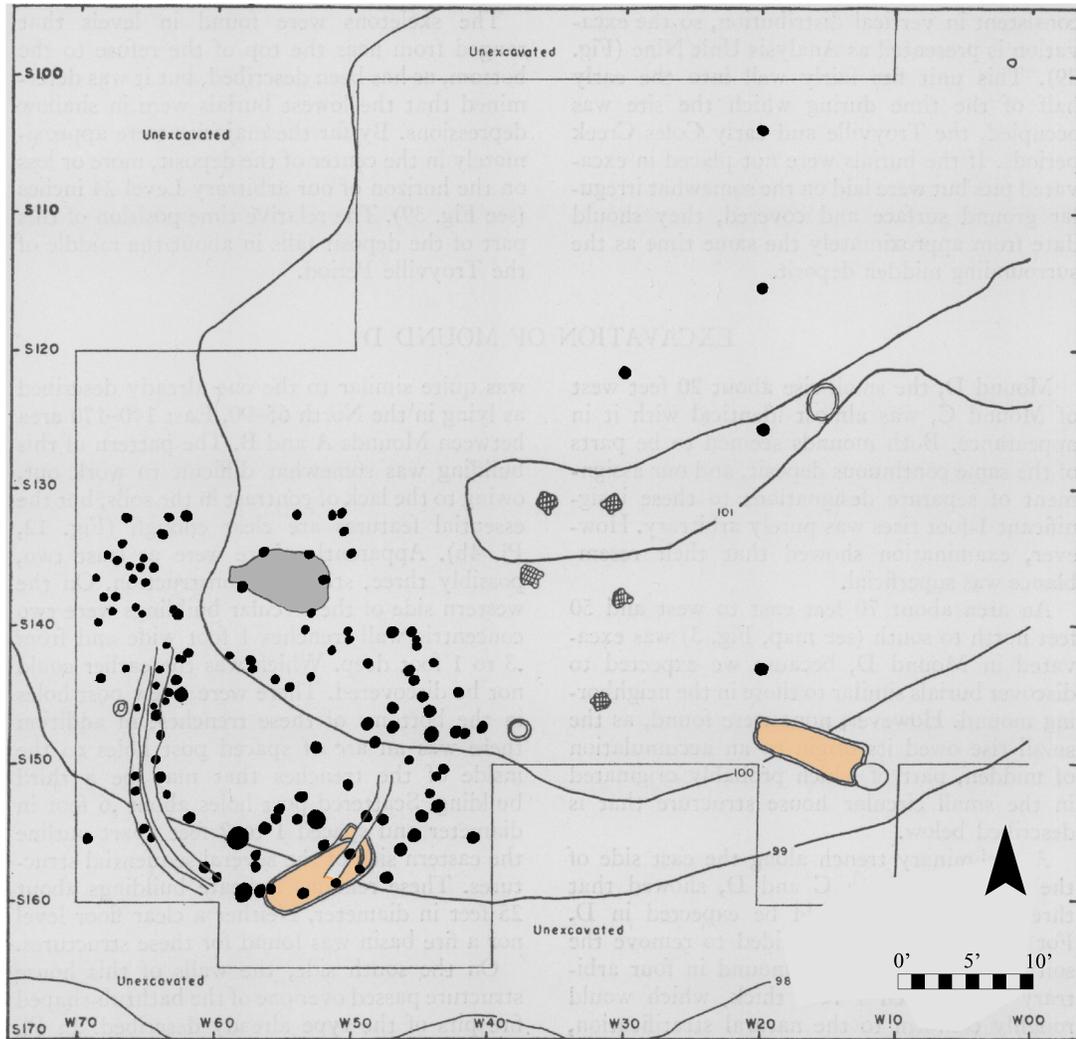
Figure 29. Features under Greenhouse Mound D. Pit features are colored gray. Bathtub-shaped pits are colored orange. Adapted from Ford (1951:Figure 12).

Mound D Submound. A circular structure (Figure 29) was evident underneath Mound D that featured posts with an average eight inches in diameter and spaced an estimated median of 8.5 inches apart. The structure had an approximate diameter of 30 feet. These posts were at least partially placed in wall trenches, and the presence of multiple wall trenches to the west and south of the structure likely indicates rebuilding. Posts overlay a bathtub-shaped pit to the south, and a pit to the north, part of evidence of frequent cultural activity underneath Mound D (Ford 1951: 45). Large posts with a diameter of over 15 inches lie within the southern portion of the structure. They may precede or supersede the structure, given their incongruous diameter, and not be contemporaneous with the other postholes.

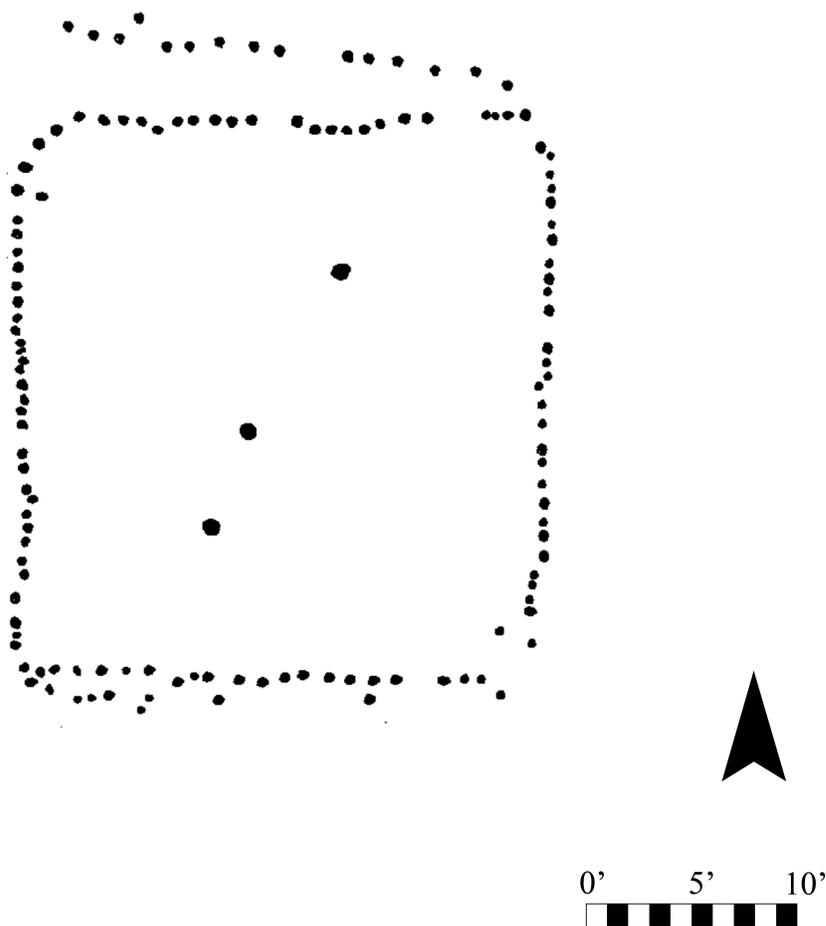
Figure 30. Feature 274, Mound A, Nick Farm site. Adapted from Schwab (1998:Figure 2).

Feature 274. This structure (Figure 30) has a rectangular form with postholes of a median 6.6 (6) inches in diameter, with a median spacing of 3.9 inches (2-6 inches). The structure has dimensions of about 26 feet by 24 feet, with closed corners. Three postholes in the middle of the structure were greater than 10 inches in diameter. These may have held supports of some kind, but they were asymmetrically placed within the structure. A line of postholes spaced wider than the postholes of the wall itself—at a median 11 (6-12) inches apart—ran west from the northeast corner of the structure. Schwab interprets this as a possible windscreen or privacy wall for an entrance (Schwab 1998:22).

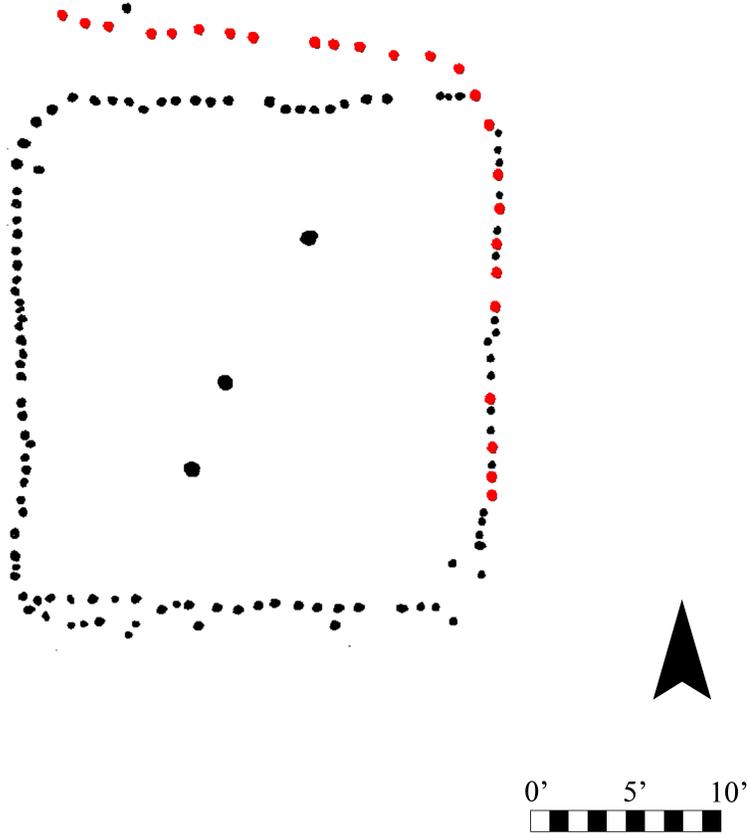
Figure 31. Posts (in red) with diameters greater than six inches extend into the eastern wall of Feature 274 from the extraneous wall. Adapted from Schwab (1998:Figure 2).

between the extraneous and eastern walls may lend some insight into the construction of the dwelling. Perhaps, rather than a windscreen, the extraneous line of postholes represented an aborted wall, for which posts were pulled when the line of posts was adjusted to a more appropriate angle.

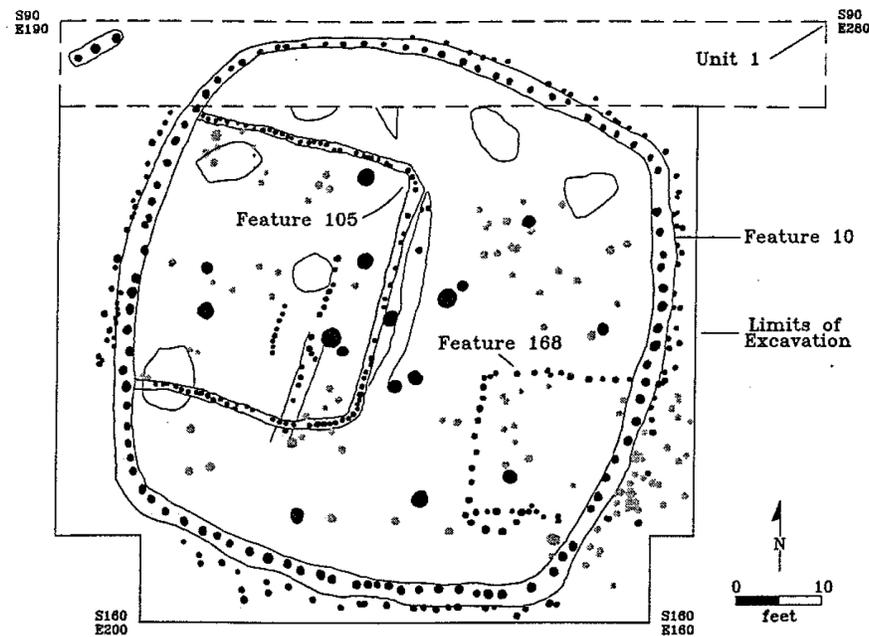
Figure 32. Structures under Mound B, Nick Farm site. Outlined shapes are areas of burned clay, possible hearths. Image from Schwab (1998:Figure 4).

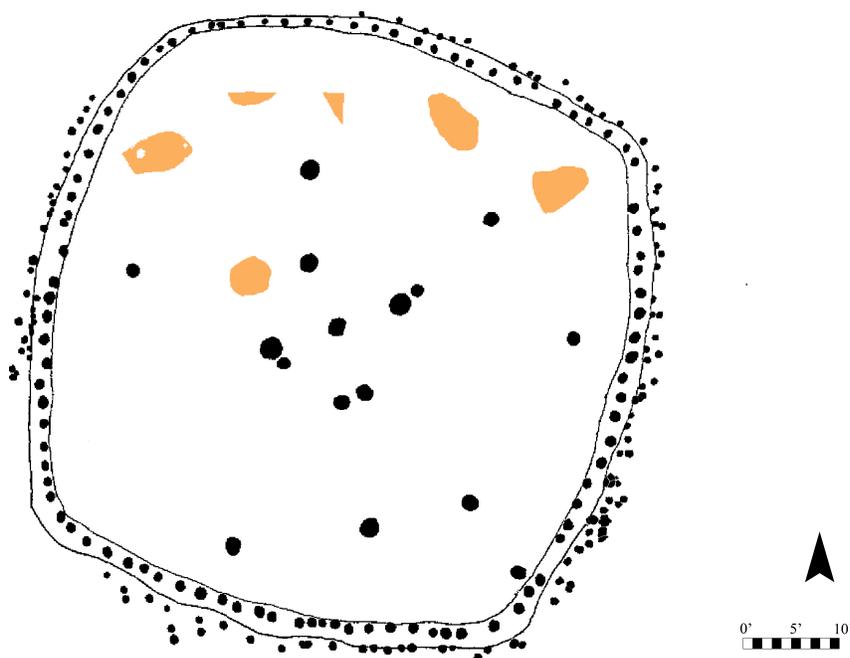
Figure 33. Feature 10, under Mound B, Nick Farm site. Hearths, possibly associated, are colored orange. Adapted from Schwab (1998:Figure 4).

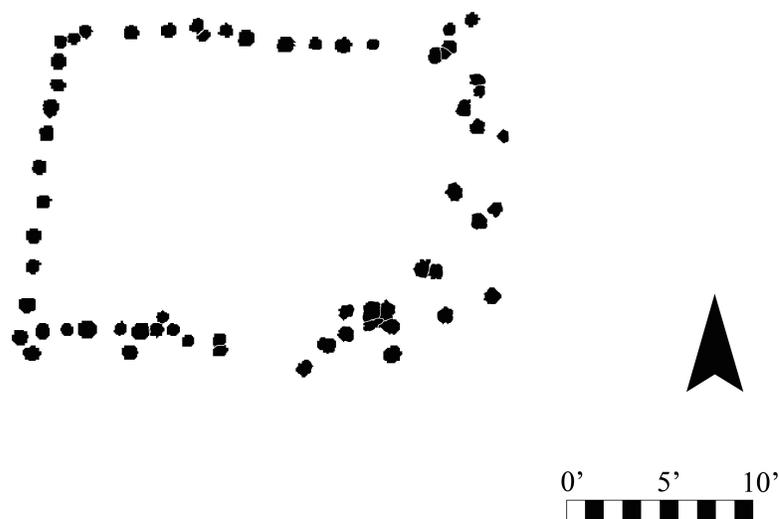
Figure 35. Feature 168, under Mound B, Nick Farm site. East wall obscured due to intrusion from Feature 10. Adapted from Schwab (1998:Figure 4).

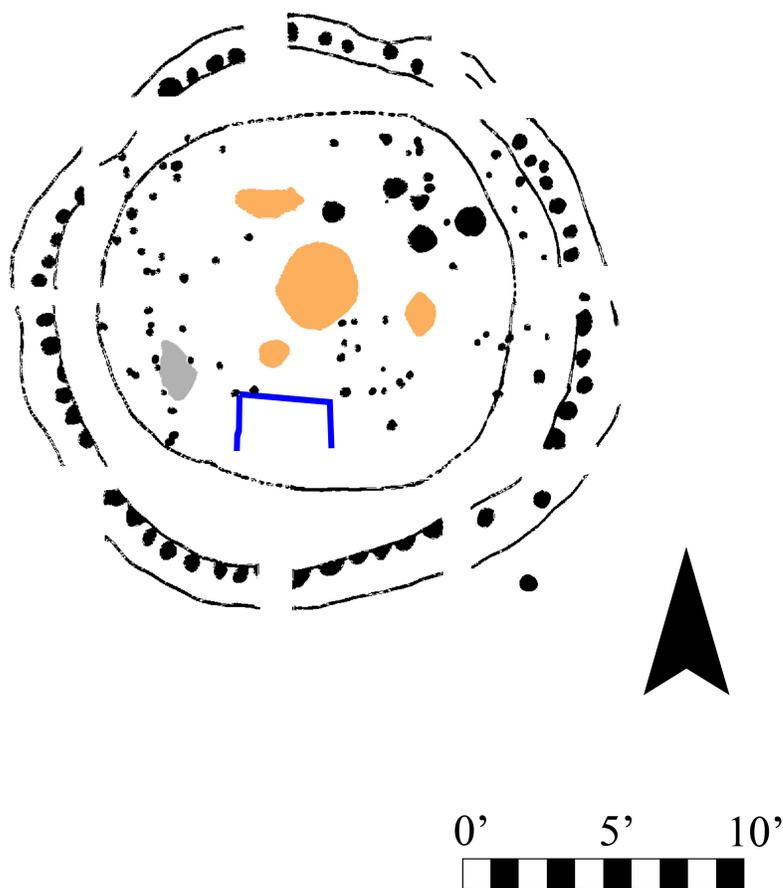
Figure 36. Feature 3 under the mound at St. Gabriel site. The clay embankment is outlined to the inside of the wall trench. The hearth and burned areas are colored orange. The ramp is outlined in blue. Gaps in the map are areas within balks. Adapted from Woodiel (1993:Figure 13).

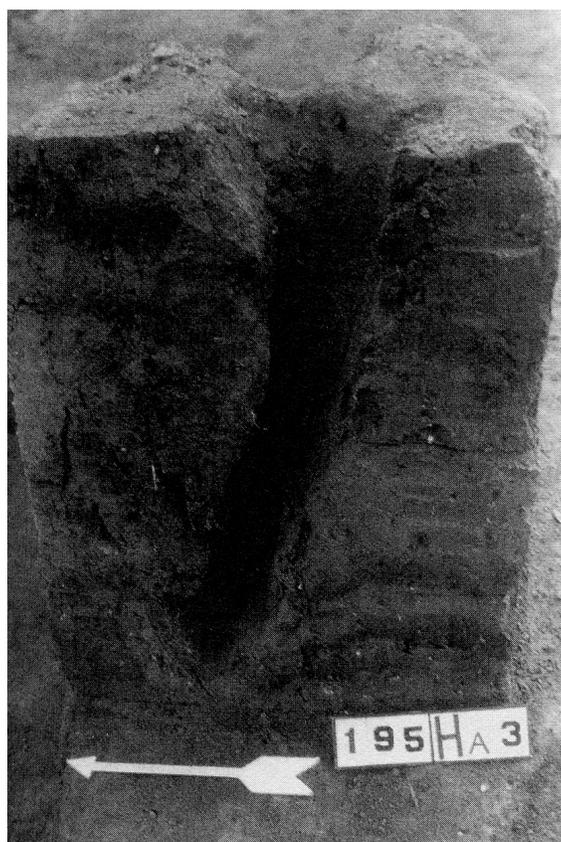
Figure 37. Outward-leaning postmold from house 65 at the Hixon site, Tennessee. The associated structure featured bent-post wall trench construction. Horizontal wedges on the inside of the post left the post in this position, once tension was applied. Excerpted from Lewis and Kneberg (1995:Figure 4.1).

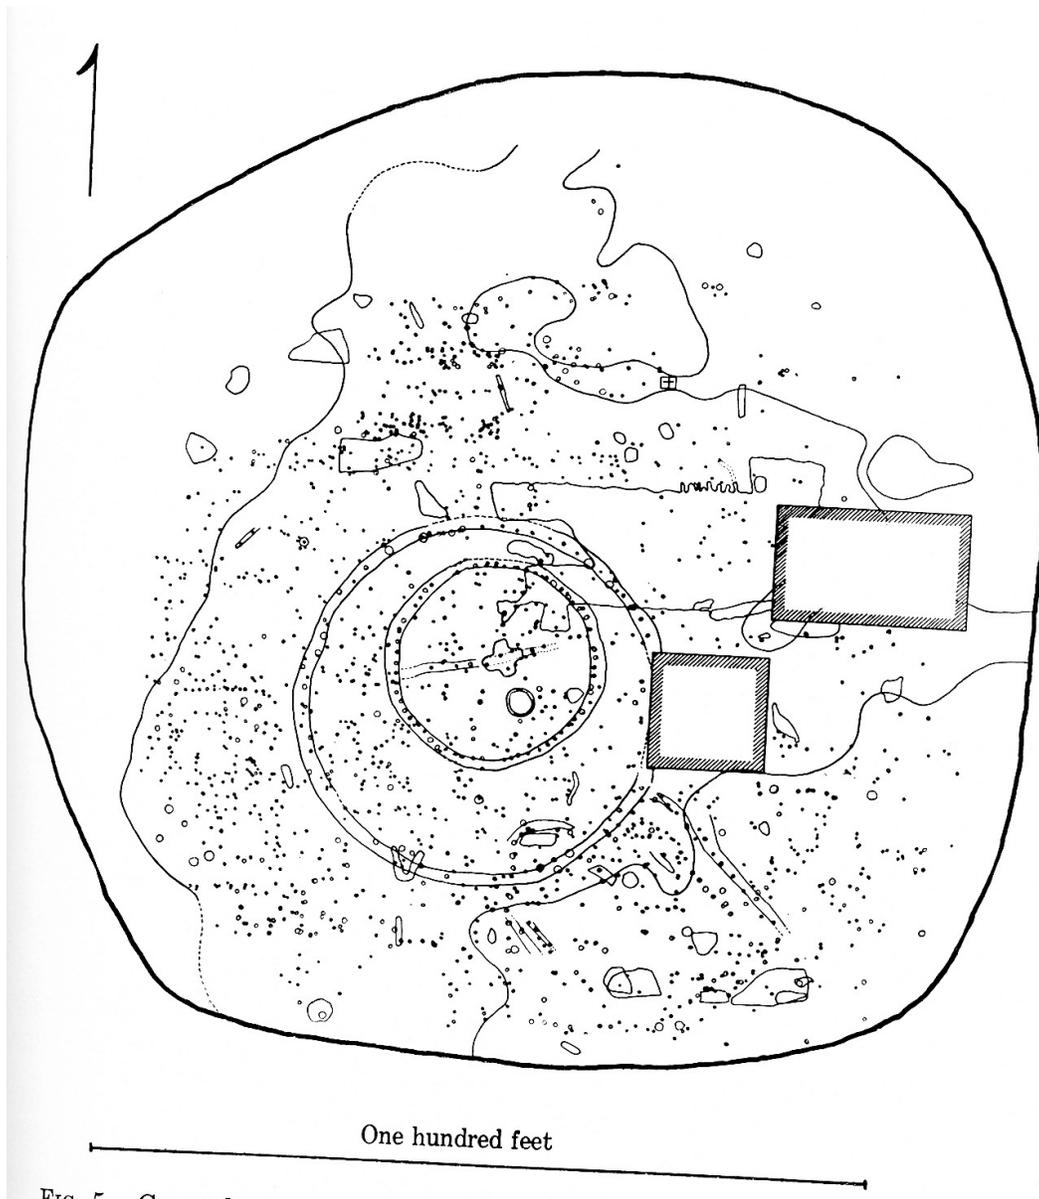
Figure 38. Features found at Level 1, Mound A, Medora site. The interior wall trench includes a cruciform hearth and a circular platform to the south. Adapted from Quimby (1951:Figure 5).

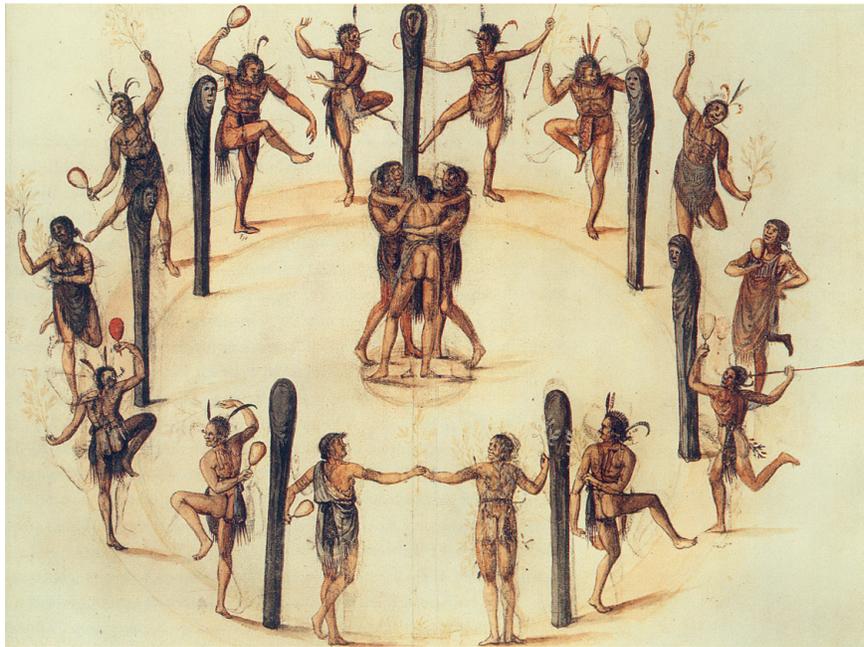
Figure 40. Watercolor by John White depicting an enclosure of posts in coastal North Carolina in the 16th century. Image courtesy of Wikimedia Commons.

The enclosure at Gordon is simply too large to be covered without roof supports. With posts in its postholes, this well-planned circular feature might have resembled the enclosure depicted by John White in North Carolina (Figure 40). Such a comparison makes ritual use seem most appropriate. In any case, the widely spaced posts of the enclosure likely made any activities widely accessible in the space inside.
